SAFETY ALERT

Installation Verification of BRS Pickup Collar

SA-ASTM-CTLS-05
SA-ASTM-CTHL-03
SA-ASTM-MC__-04

Verifying the correct installation of the pick-up collar to the extractor of the BRS 1350 HS Airframe Emergency Parachute System.

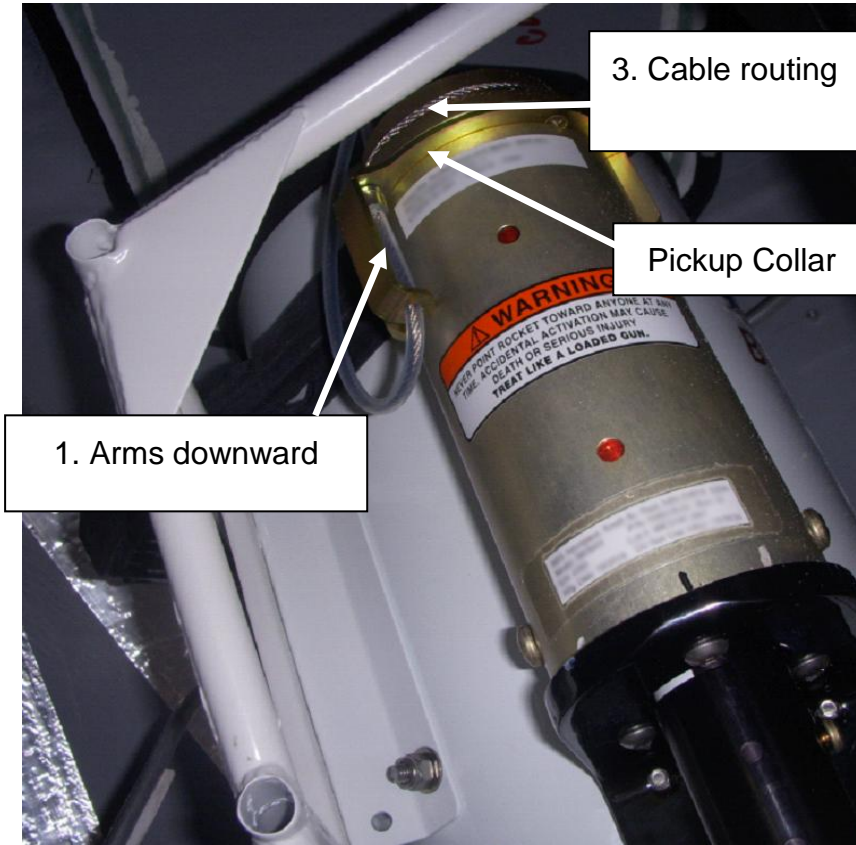
Fig. 1 shows the correct extractor installation. The component that slides over to top of the extractor, and is attached to the launch tube with two aluminum screws from the top, is called the pickup collar.

1. The pickup collar is installed as shown on Fig. 1, with the two arms guiding the steel cables towards the AEPS harness pointing **downwards**. See Fig. 2 for additional reference.
2. The pickup collar installed to the top of the extractor has a long shaft, that covers the extractor as such nearly up to the red tip of the extractor, as shown on Fig. 2

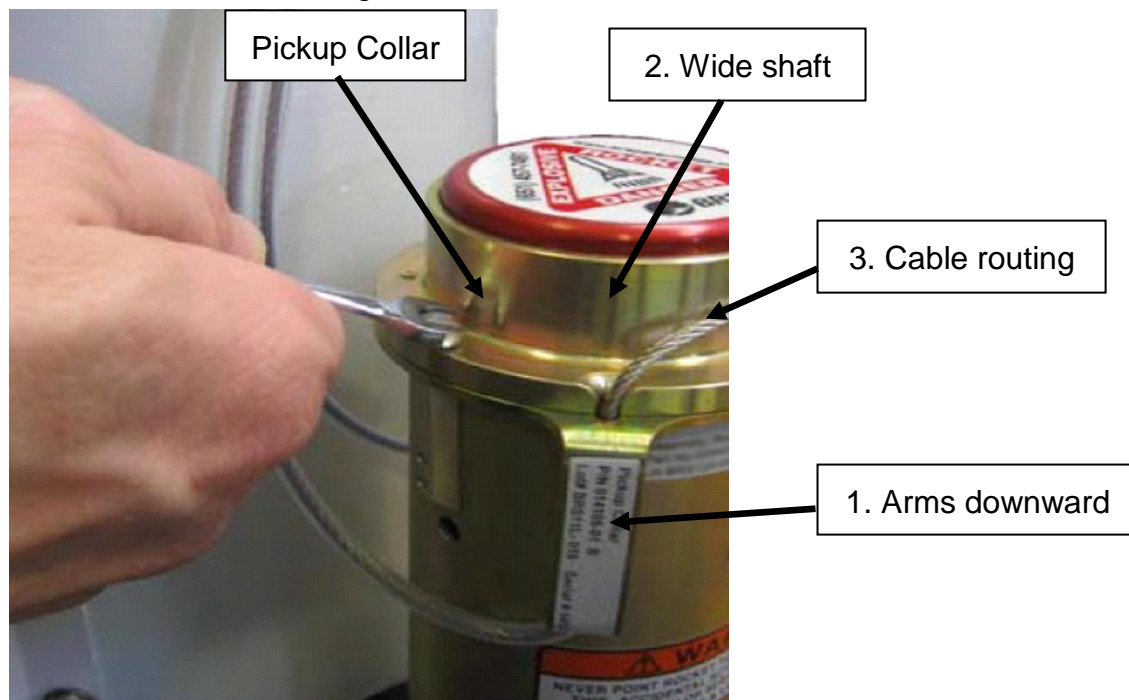
Fig. 2 – CORRECT installation of the pickup collar

Fig 2 shows an Extractor prior to installation to the aircraft, where the correct orientation is visible. The labels identify the installation details to be checked during this inspection.

The following facts must be verified, see Fig. 2 showing the items with the same numbering as indicated in the following checklist:

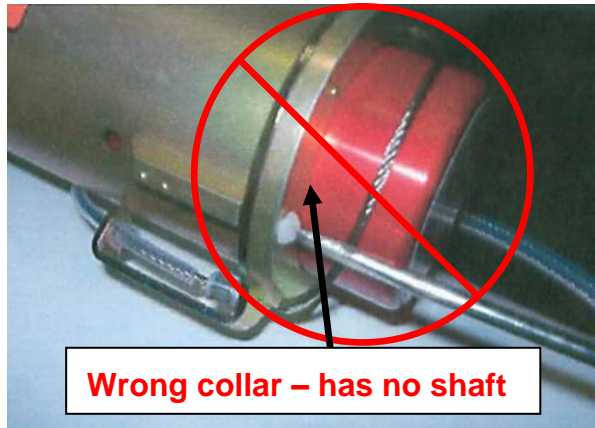
Fig. 3 **WRONG** pickup collar

For comparison: The **WRONG** collar has no shaft, as shown on Fig 3.

1. Pickup collar arms are pointing upwards
2. Pickup collar does not have the long shaft

Then conduct correct installation of pickup collar, follow instructions of [1].

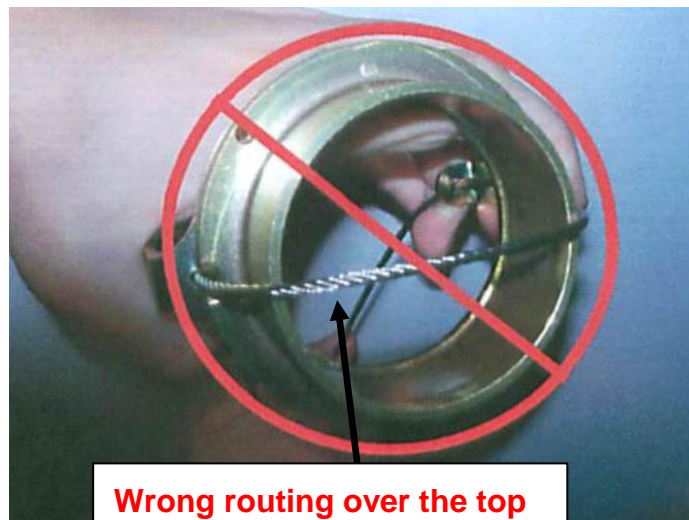
Fig. 4 **WRONG** cable routing

3. The steel cable is routed on the outside of the pickup collar shaft. By no means it may be routed over the top of the extractor. For comparison: See Fig 4 for incorrect routing.

When the steel cable is routed over the top of the extractor, then move the steel cable to the side of the extractor as shown on Fig. 4. It may be necessary to remove the pickup collar from the launch tube in order to get the cable re-routed. In this case follow relevant instructions provided by [1] for correct installation.

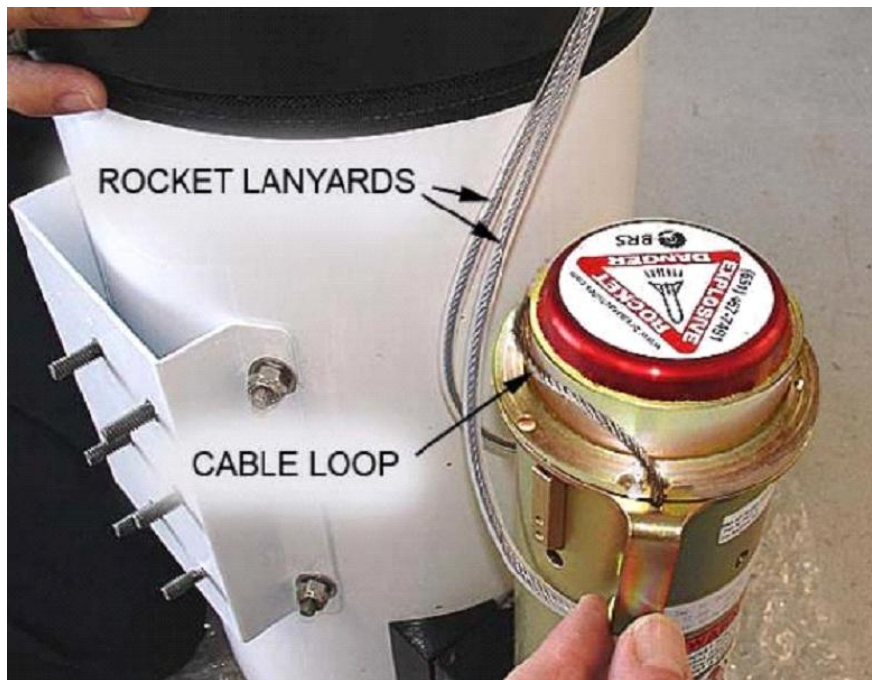
Fig.4

Following completion of this instruction, the pickup collar must be installed as shown in Fig 4. Fig 4 again is taken from a non installed system, for better visibility.

▲Warning: Ensure that cable loop is placed to side of the rocket - not over the top. Cable routed over top will cause deployment failure, possibly resulting in death or serious injury.
