SAFETY ALERT

Securing of control system bolts

SA-LTUL-CT__-01;

SA-LTUL-CT2k-01;

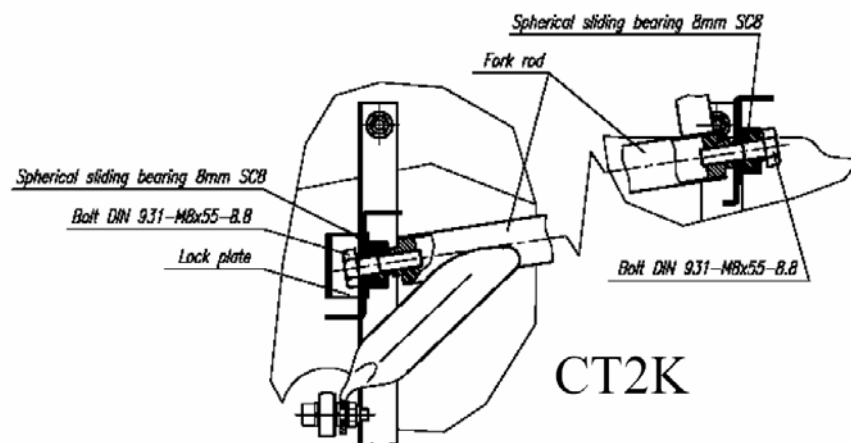
1. Because of corrosion at the CT built 1997 a torsion bearing was sized. Out of this reason the pin in the bearing was loosened and screwed out. First CT2K was built in 2000. Additional lock plates are stipulated.

- It has to be insured that the lubrication of bearing and hinges according the flight & maintenance manual is made accordingly.
- The bearing pins and the flap connecting bolt have to be checked if fixed. If loose, they have to be tightened and secured with loctite (hard) or a safety pin.
- The cables for airbox & heating have to be cut to minimal length

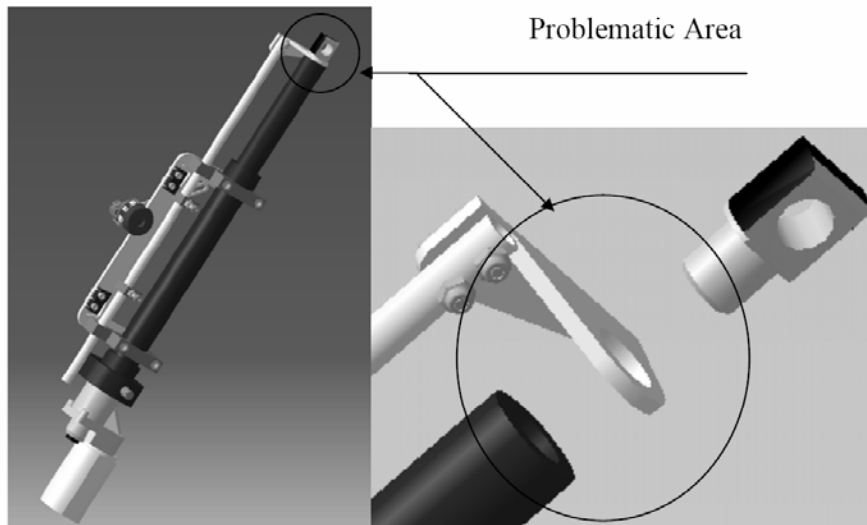
For fixing of tip a bolt A2 913 4x6 could be used
