SERVICE BULLETIN	
	Flight Design GmbH Sielminger Str. 51 D-70771 L.-Echterdingen Tel +49 (0)711 90287-0 Fax +49 (0)711 90287-99 E-Mail: airworthiness@flightdesign.com	SB-ASTM-CTSW-07 Revision 00
		Date of Initial Publication: 30-Nov-2009 Publication Date of this Revision: 30-Nov-2009

SERVICE BULLETIN

Stabilizer Rear Wall Stiffening SB-ASTM-CTSW-07

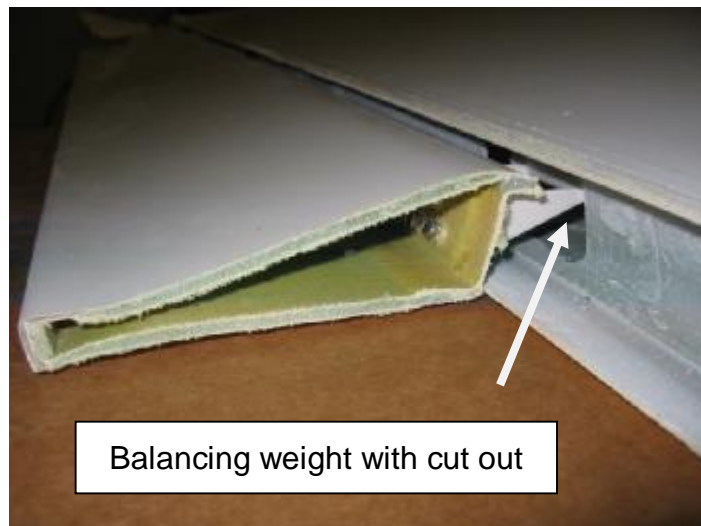
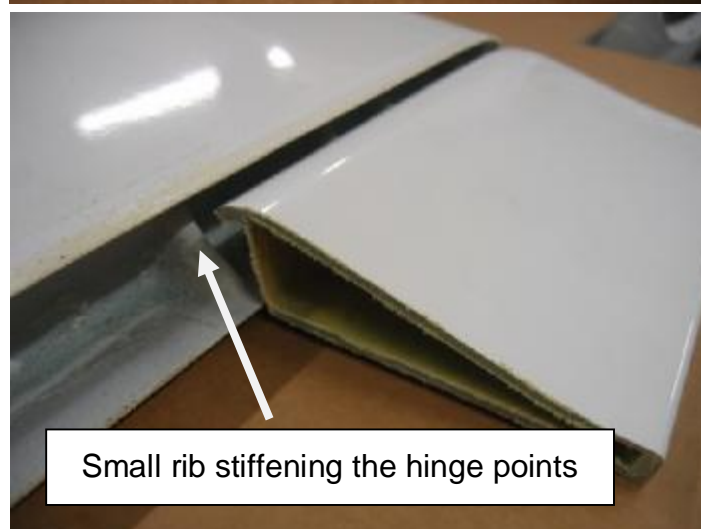
4.2 Pictures

Increasing play in the trim tab control system can lead to vibrations in the trim tab in flight at high speeds. This vibration can be clearly felt by the pilot when exceeding a certain speed and stops again when slowing down.

Pictures in the Appendix of this SB illustrate balancing weights with cut outs and the small ribs, which supports each hinge point.

Stiffening of the rear wall of the stabilizer by installation of ribs in the cut-outs for the balancing weights, and direct support of the individual hinge points with small ribs.
