# SERVICE BULLETIN

**Garmin SL30 and SL40**

**Comm Radio Spurious Emissions Correction**

**SB-SECS-CT\_\_-03**

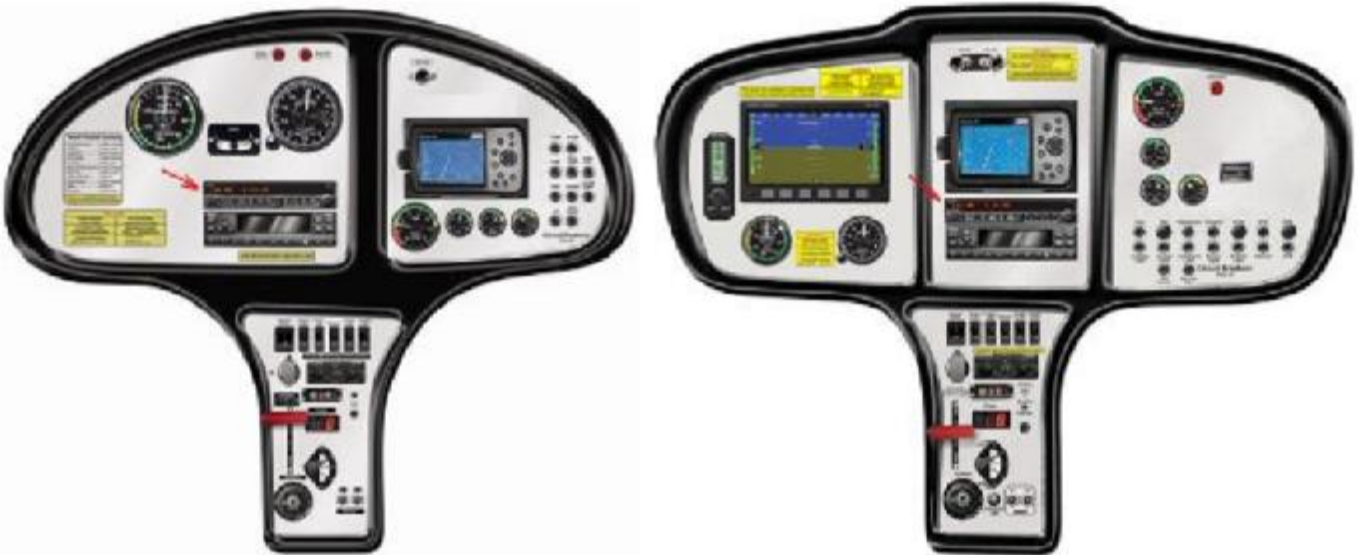
Fig. 1

Typical installation locations of the units are shown in Fig. 1.

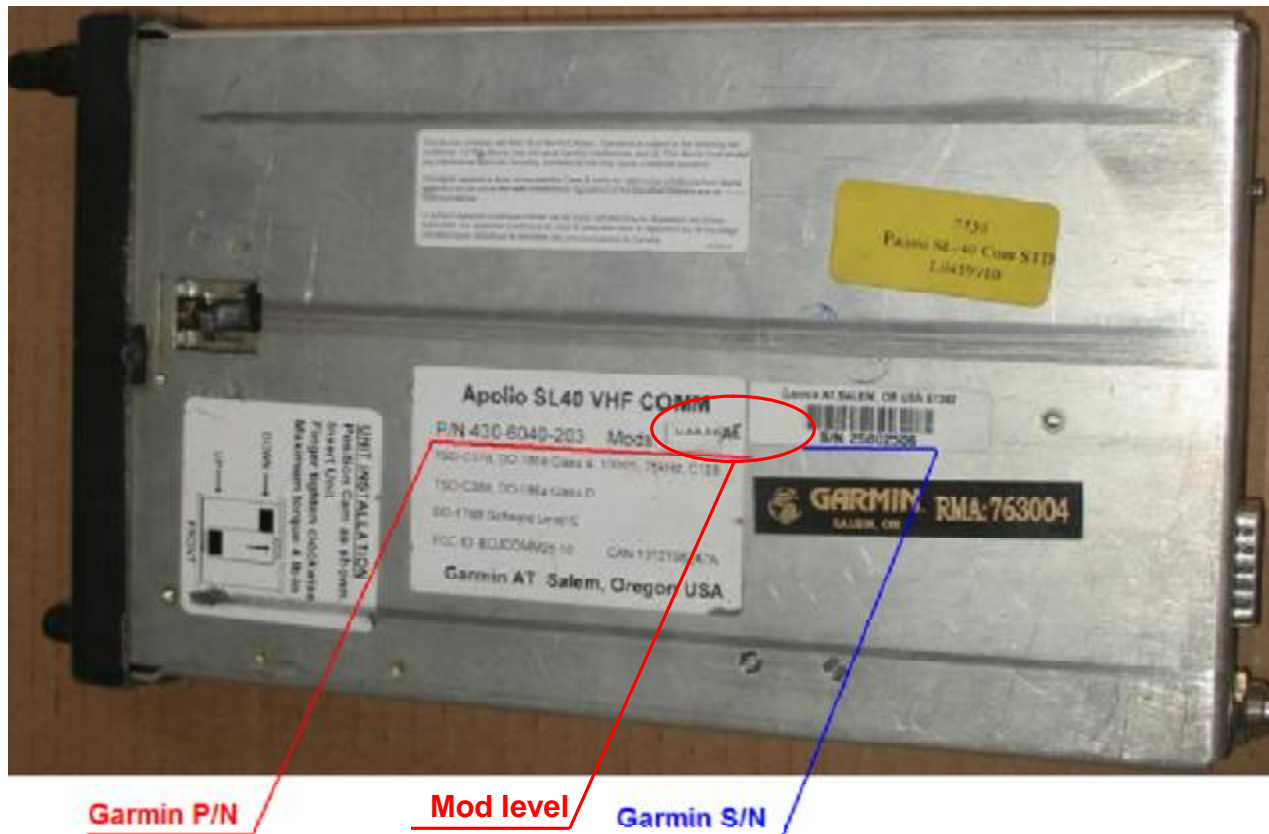
Fig. 3

Identify the Mod level from the nameplate on the bottom side of the unit. P/N, Mod level and S/N of the individual unit are shown in Fig. 3.
