Safety Alert	
	Flight Design GmbH Zum Tower 4, D-01917 Kamenz Tel.: +49 (0)3578 37335 0 Fax: +49 (0)3578 37335 69 airworthiness@flightdesign.com	SA-ASTM-CTLS-04 Revision 01
	Date of Initial Publication: 19-Dec-2013 Publication Date of this Revision: 25-Nov-2014

CTLSi Engine Installation Redundancy Diagnosis SA-ASTM-CTLS-04

Diagnosis of the Regulator board A and B connection on the engine Rotax 912iS. Update of the harness routing to make a wrongful connection physically impossible.

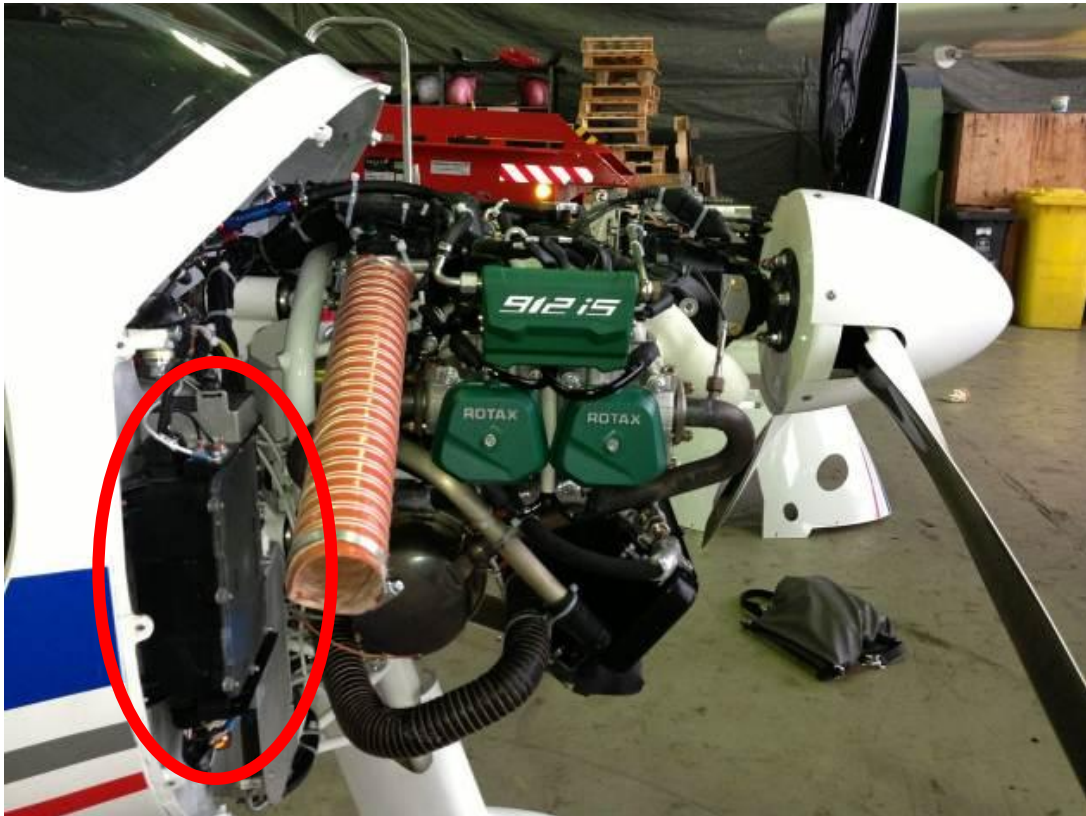
Fig.1

Identify the fuse box on the right side of the firewall (in flight direction). See Fig.1.

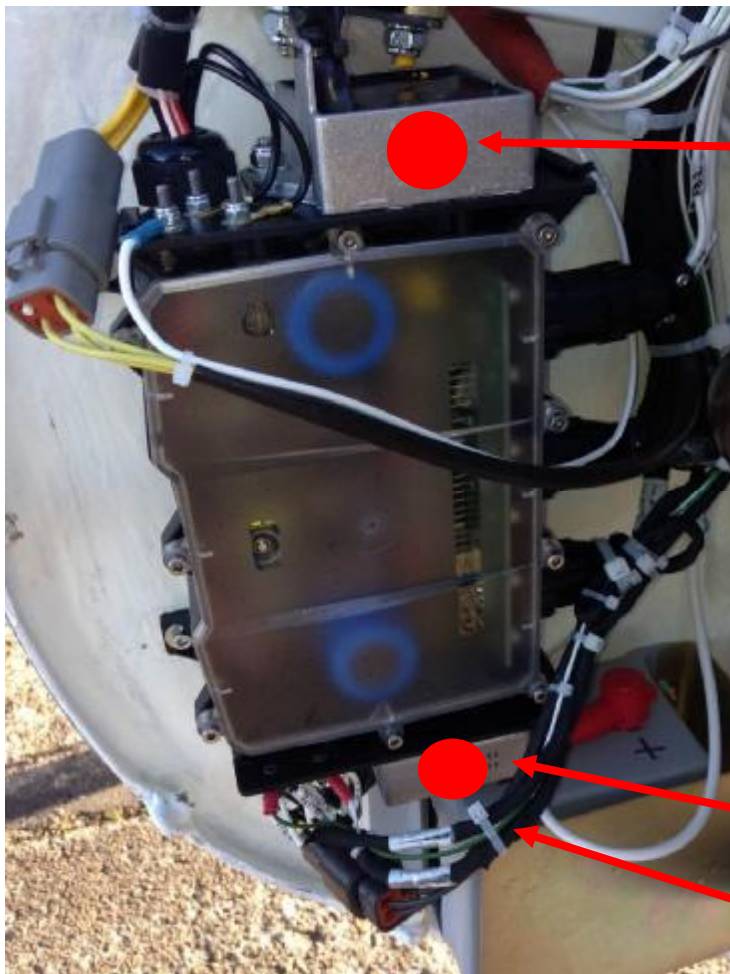
Fig.2

Use a Multimeter to verify electrical ground connection between the regulator Board A and B (red marked points on the Fig.2).

Regulator Board B
electrical Ground

Regulator Board A
electrical Ground

Regulator Board A
Ground Wires

There **must not** be an electrical connection between Regulator Board A electrical ground and Regulator Board B electrical ground.

If there is ground contact, the reason may be that the Lane A harness ground wires are wrongly connected with Lane B regulator board (upper regulator, above the fuse box). In this case, remove the Lane A wiring harness end (also marked with a label as "Lane A") from the Lane B regulator board. Connect this wiring harness end to the Lane A regulator board, which is the one below the fuse box. Fig. 2 shows the correct step. Re-do the test with the multimeter as above. The aircraft may be operated again, when there is no more ground contact between the two regulator boards. If the problem persists, please contact Flight Design for further instruction.

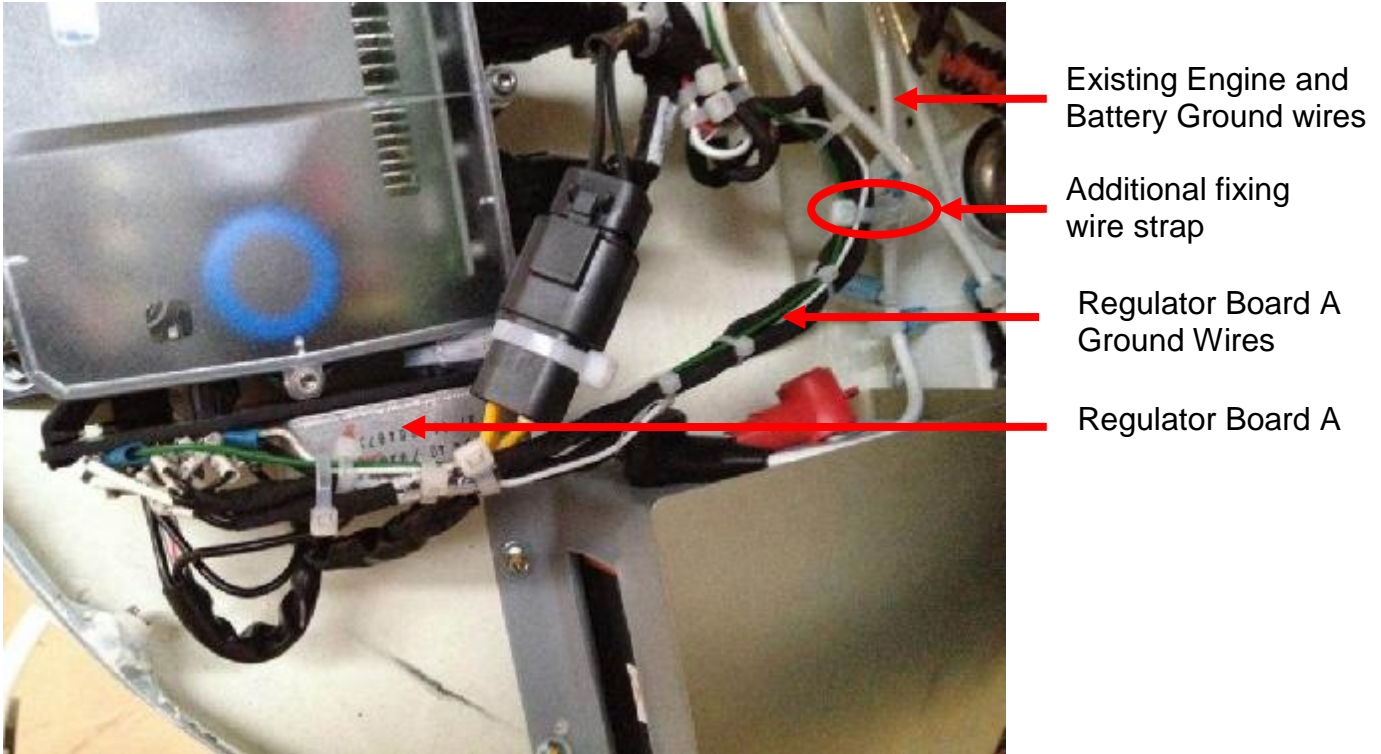
Fig.3

Check Lane A ground wires length: it has to be short enough so that it cannot be connected inadvertently to Regulator Board B during maintenance. If the wires are too long, additionally fix Lane A ground wires to existing engine/battery ground wires using wire strap following Fig.3.

To avoid the possibility for a re-occurrence of this mistake, add an additional harness fixation to the questionable harness end, that makes connection to the wrong board physically impossible.

Check that all wires are secured properly and protected from unintentional damages. Cut extra length of wire strap. Make sure it is removed from the engine compartment.
