SAFETY ALERT

Trim Tab Reinforcement

SA-ASTM-CTSW-03

FLIGHT DESIGN USA SAFETY DIRECTIVE No.15

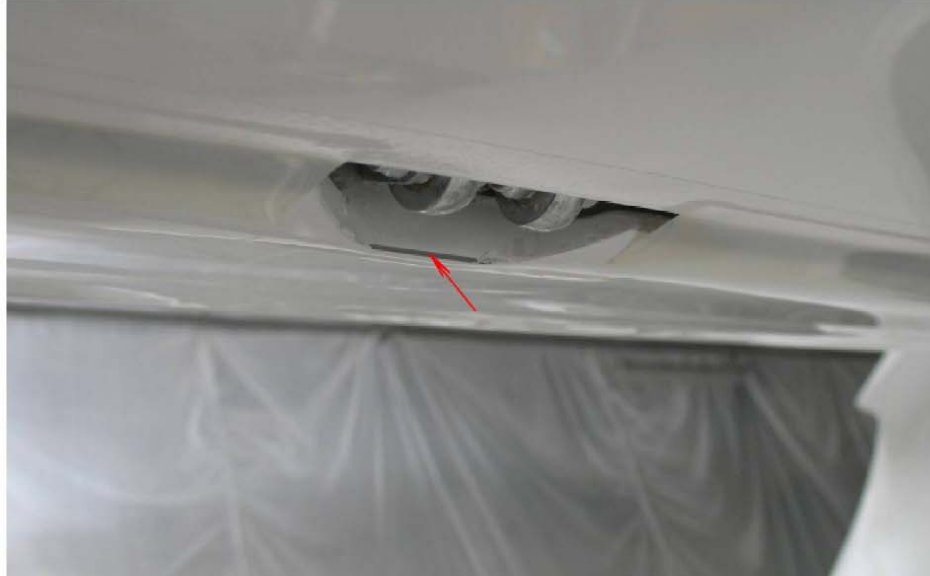
Recently a CTSW 2007 exhibited significant stick vibration in pitch during high speed flight. The aircraft remained controllable, and, after slowing down, the vibration stopped. The investigation ruled out the balancing of the trim tab as these are mass balanced at the factory in accordance with detailed flutter and ground vibration tests and analysis. The investigation did determine that a pitch control vibration could result from the de-bonding in the area of the Trim Tab Bracket (Part No. KA 3011110) from the trim tab (anti-servo tab) as evidenced by a crack located at the attachment point. (Fig. A)

Fig. A: Inspection area: Trim tab control horn attachment point
(Seen from underneath the stabilator)

Flight Design is mandating an immediate inspection of the Trim Tab Bracket attachment area, with special consideration to the composite structure of the trim tab. The inspection will be performed before the next flight, and thereafter, prior to the first flight of the day. When inspecting the trim tab, the surface should be submitted to a gentle load by hand in order to expose any potential damage.

If cracks are found in the area of bonding (attach point) (Fig. A), the aircraft must not be flown until the mandated reinforcement procedure has been completed.

Regardless whether cracks are found, all aircraft listed in this Safety Directive are subject to the modification procedure within the next 25 flight hours, or at the next maintenance interval, whichever occurs first.

As an additional precaution, the maximum airspeed for the affected aircraft will be limited to V_H , 120 KIAS (maximum speed in level flight with maximum continuous power) in all regimes of flight including descending flight until the mandated procedure has been completed.

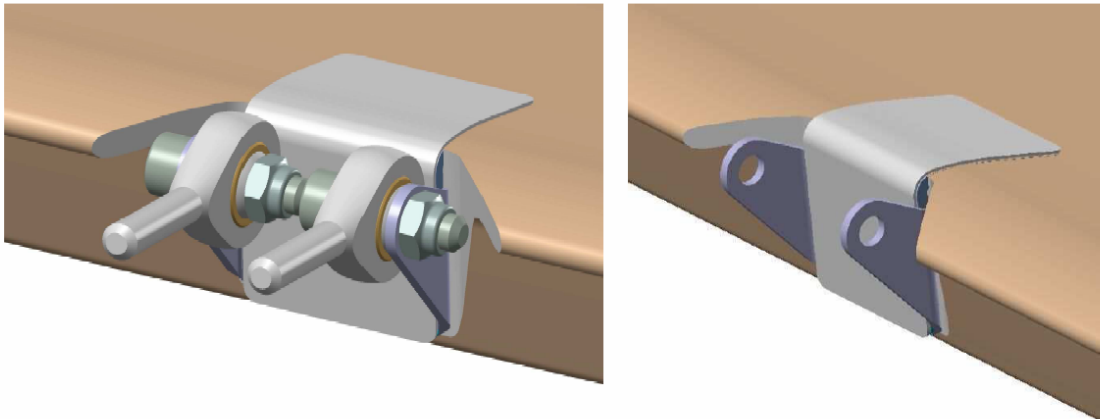
Fig B1 & B2: Reinforcement installed to the trim tab
(Tab shown bottom surface facing up)

The reinforcement procedure consists of reinforcing the point at which the control horn is bonded to the trim tab by the addition of specifically designed part manufactured by Flight Design (WA 3011011). The part is glued (bonded) to the control rod bracket and the lower trim tab surface with resin and delivers a secondary load path for the trim tab control forces.

The modification can be done without removing the trim tab, and does not require painting. (Figs.B1 & B2)

The procedure shall be completed according to Flight Design document: 070625- Trim Tab Reinforcement Procedure that accompanies this Safety Directive, and supplemented by the Maintenance Manual.
