SAFETY ALERT

Trim Tab Reinforcement

SA-LTUL-CTSW-03

Technical Advice No.13 – revision 1

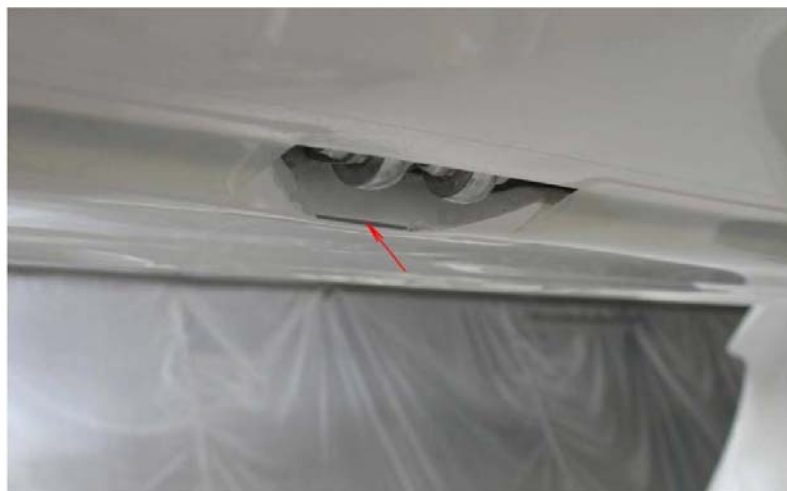
Fig. A: Inspection area: Trim tab control horn attachment point
 (Seen from underneath the stabilator)

The investigation did determine that a pitch control vibration could result from the upper and lower trim tab (anti servo tab) skin exactly in the area of the Trim Tab Bracket (Part No. KA 3011110) as evidenced by a crack located at the attachment point. (Fig. A)

Flight Design is mandating an immediate inspection of the Trim Tab Bracket attachment area, with special consideration of the trim tab composite structure. The inspection will be performed before the next flight and thereafter prior to the first flight of the day. When performing the

inspection, the trim tab has to be carefully loaded by hand in the center area, in order to expose potential damage.

If cracks are found in the area of bonding (attach point) (Fig. A), the aircraft must not be flown until the mandated reinforcement procedure is completed.

Regardless whether cracks are found, all aircraft listed in this Safety Directive are subject to the modification procedure within the next 25 flight hours, or at the next maintenance interval, whichever occurs first.

As an additional precaution, the maximum airspeed for the affected aircraft will be limited to 120 KIAS = 222 km/h IAS (maximum speed in level flight with maximum continuous power) in all regimes of flight including descending flight until the mandated reinforcement procedure is completed.

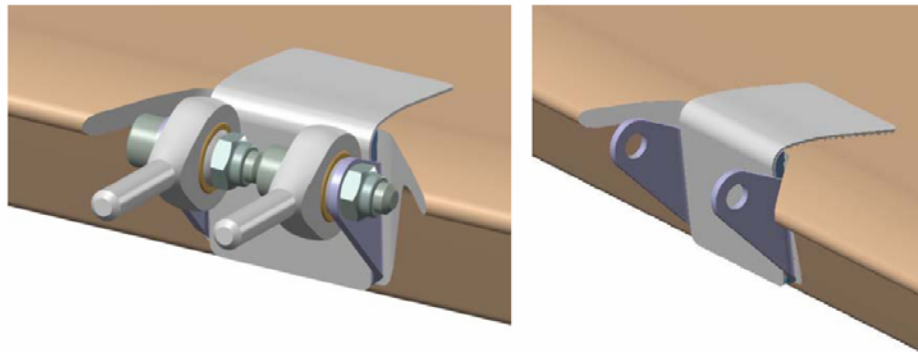
Fig B1 & B2: Reinforcement installed to the trim tab
(Tab shown bottom surface facing up)

The reinforcement procedure consists of reinforcing the point at which the control horn is bonded to the trim tab by the addition of specifically designed part manufactured by Flight Design (WA 3011011). The part is glued (bonded) to the control rod bracket and the lower trim tab surface and delivers a secondary load path for the trim tab control forces. The modification can be done without removing the trim tab, and does not require painting action. (Figs.B1 & B2)

The procedure shall be completed according to Flight Design document: "070625 – TRIM TAB REINFORCEMENT PROCEDURE" that accompanies this Safety Directive, and supplemented by the Maintenance Manual.
