# SAFETY ALERT

## Securing of control system bolts

**SA-SECS-CT\_\_-01;**  
**SA-SECS-CT2k-01;**

Type: CT  
 Model: CT, CT2k,  
 Serial Number: All serial numbers  
 Applicable Countries: All Countries where BCAR Section S standards are in effect

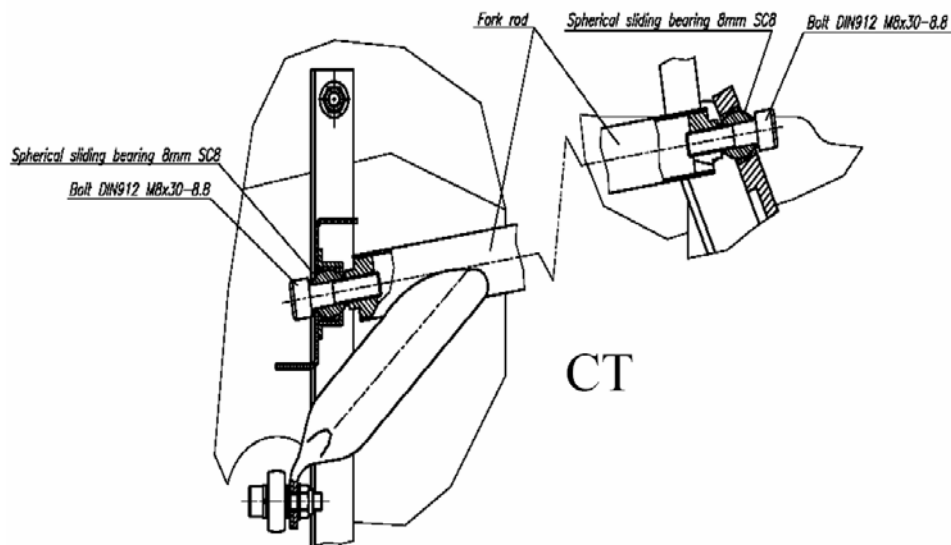
1. Because of corrosion at the CT built 1997 a torsion bearing was sized. Out of this reason the pin in the bearing was loosened and screwed out. First CT2K was built in 2000. Additional lock plates are stipulated.

- It has to be insured that the lubrication of bearing and hinges according the flight & maintenance manual is made accordingly.
- The bearing pins and the flap connecting bolt have to be checked if fixed. If loose, they have to be tightened and secured with loctite (hard) or a safety pin.
- The cables for airbox & heating have to be cut to minimal length

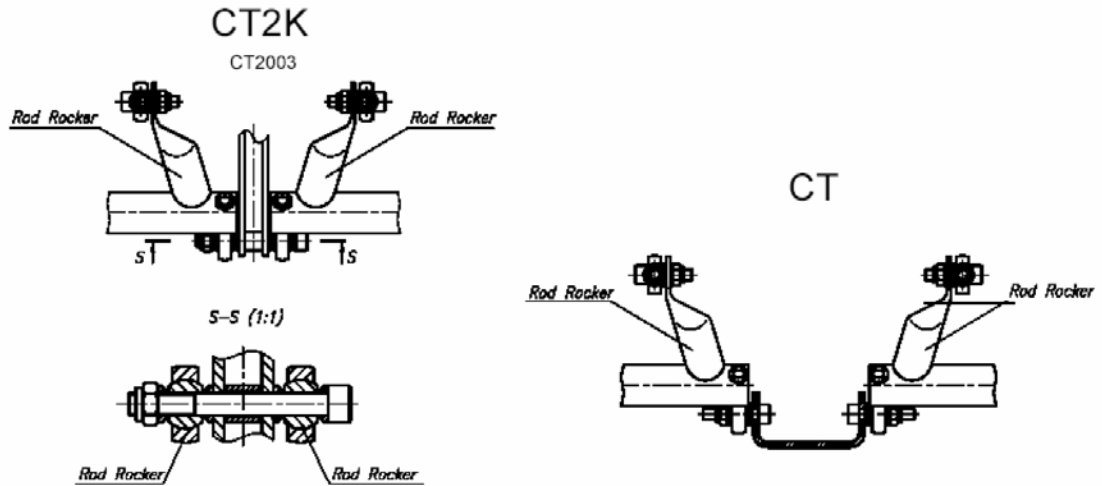
Connection of Rod Rocker

- The CT2K built 2003 the connecting bolt between the none rotating tube at the flap engine and the flaps was screwed out. It was visibly that the bolt was secured with loctite, in trials, even with none secured bolts, this could not be reached.

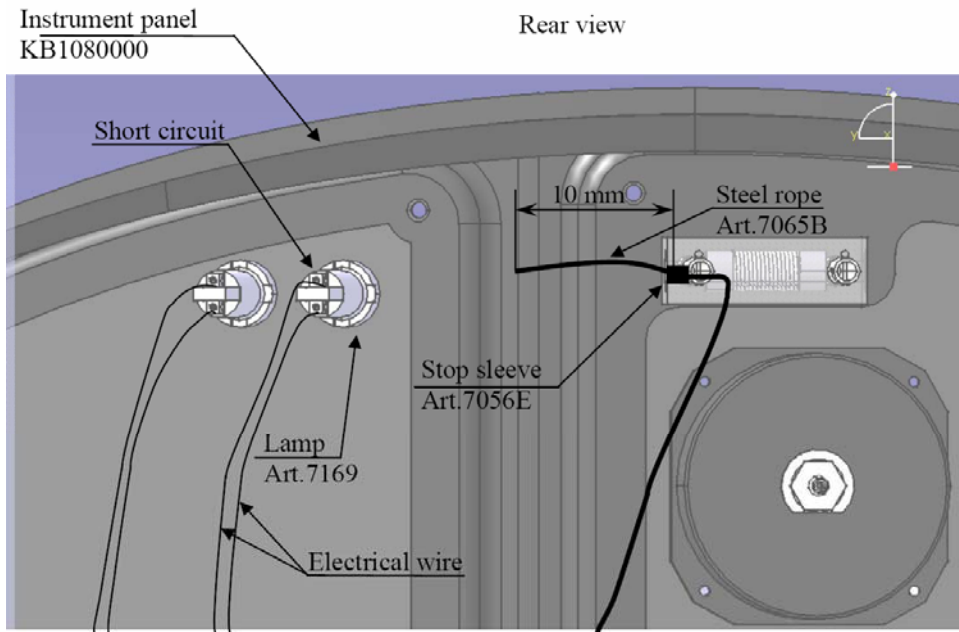
- The CT2K built in 2002 a shortcut was noted during flight. Reason was that the extended cable of the airbox lever has shortcut the warning lamps. To avoid the shortcuts, the free end of the cable must not exceed 10mm. This point has been included into the final check list.
