Rudder Centering Fork - Control Stop Replacement

SB-ASTM-CTLS-02

Type: CT

Model: CTLS

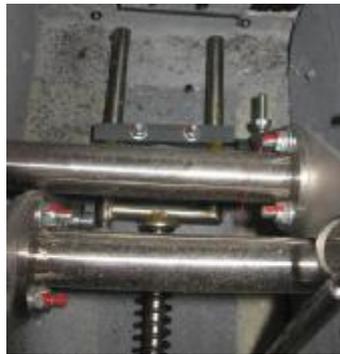
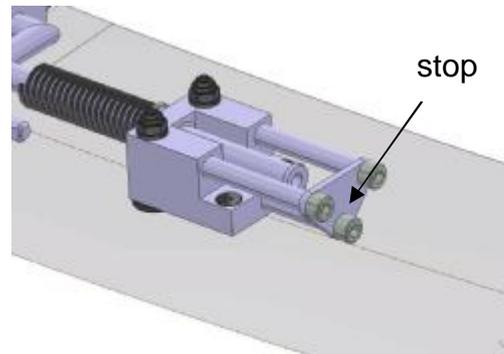
Service experience has shown that too much force on the pedals of the rudder/nose gear controls can lead to deformation of the rudder centering fork, even though the system fully fulfills all applicable certification requirements.

Overload can be achieved typically only during ground operation, such as control checks during engine run up, where the rudders are pushed intentionally against the stops. This can lead to deformation of the rudder centering fork, leading to incorrect function or jamming of the rudder control system.

This is the rudder stop system that was installed to the CTLS affected by this SB ex factory. In this system the stop is provided to the rear end of the rudder centering fork, installed to the tunnel, below the instrument board. See following Fig. 1 and Fig. 2 for illustration.

This system is the system affected by this SB.

1. Inspect installed rudder centering fork for deformation. Exchange rudder centering fork if deformed.
2. Install rudder stop plates instead of fork stop system device or, if not possible on the individual aircraft, replace with a new design fork stop system.

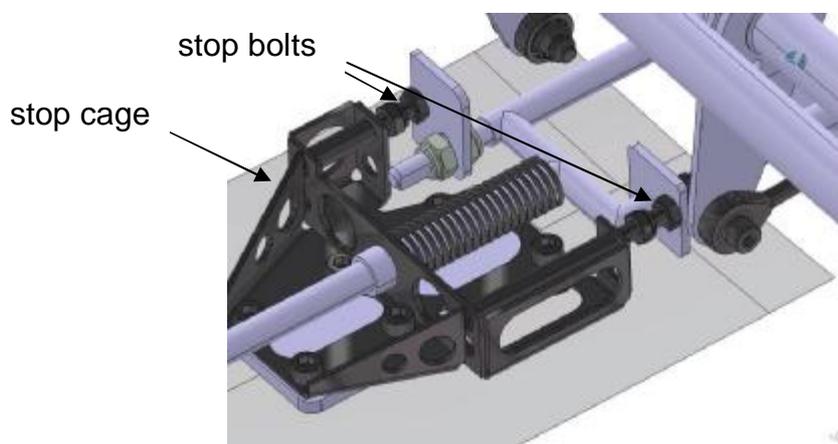
The new fork stop system provides a stop not to the rear end of the rudder centering fork, but to the thrust plates where the rudder centering fork contacts the bolt heads from the rudder pedal levers. The variant is clearly recognizable by the steel welded cage that provides the stops by means of adjustable bolts. See following Fig. 3 for illustration.

This stop device represents the valid type design and is used in serial production at the time of issuing of this SB. Only on aircrafts where the Rudder Stop Plates as by 3.1.3 cannot be used, this new fork stop system must be installed following SB [2].

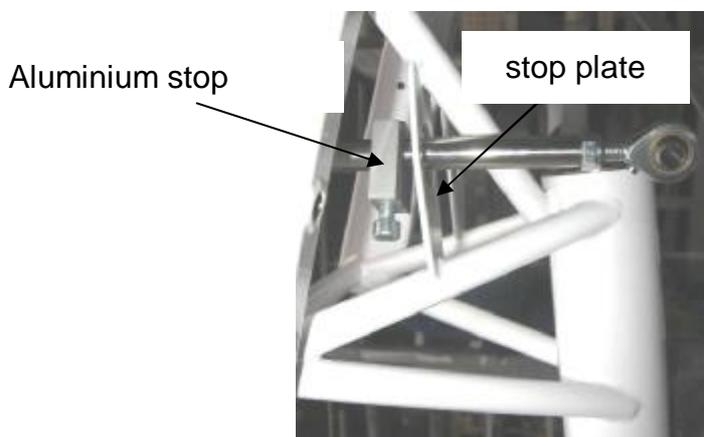
The rudder stop plates provide rudder stop not at the rudder centering fork. Aluminium stops, positioned to the control rods that connect the pedals with the nose gear steering, come to a stop against two stop plates welded to the big engine mount, in front of the firewall. See following Fig. 4 for illustration (only partially installed situation).

This stop device represents the valid type design previous to the introduction of the old fork stop system. It has been replaced in production due to the more complex adjustment principle, coupling with the rudder control rope pretension. On aircrafts where the welded stop plates are still available, this previous stop system shall be used again as it is easier and faster to be installed. The modification procedure is provided by this SB.

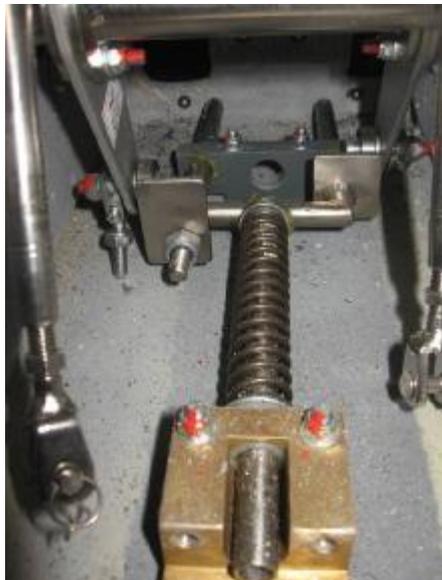
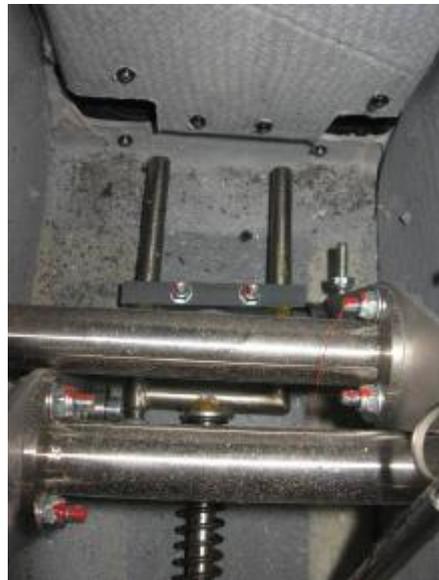
1. The rudder centering fork is not deformed, fork tubes are straight, and fork plates (small square plates shown on the fork, Fig. 5) are not bent or deformed. The correct configuration is shown on Fig. 5, 6;

When deformation is detected at the rudder centering fork, this fork must be exchanged.

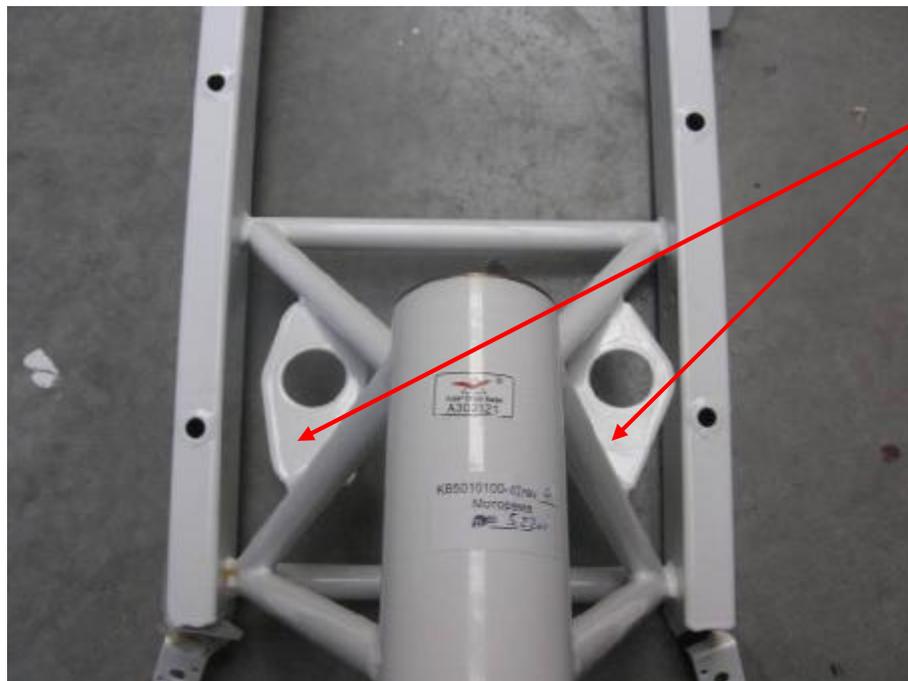
Fig.7

The engine mount is equipped with welded stop plates (Fig. 7);

When the welded stop plates are available, the stop system shall be changed towards the Rudder Stop Plates variant.

Warning: If your engine mount does not have the welded stop plates, SB [2] applies instead of all following procedures!
