# Service Bulletin

## Verification of Rescue System Cover Installation

**SB-ASTM-CTSW-13**

**SB-ASTM-CTLS-11**

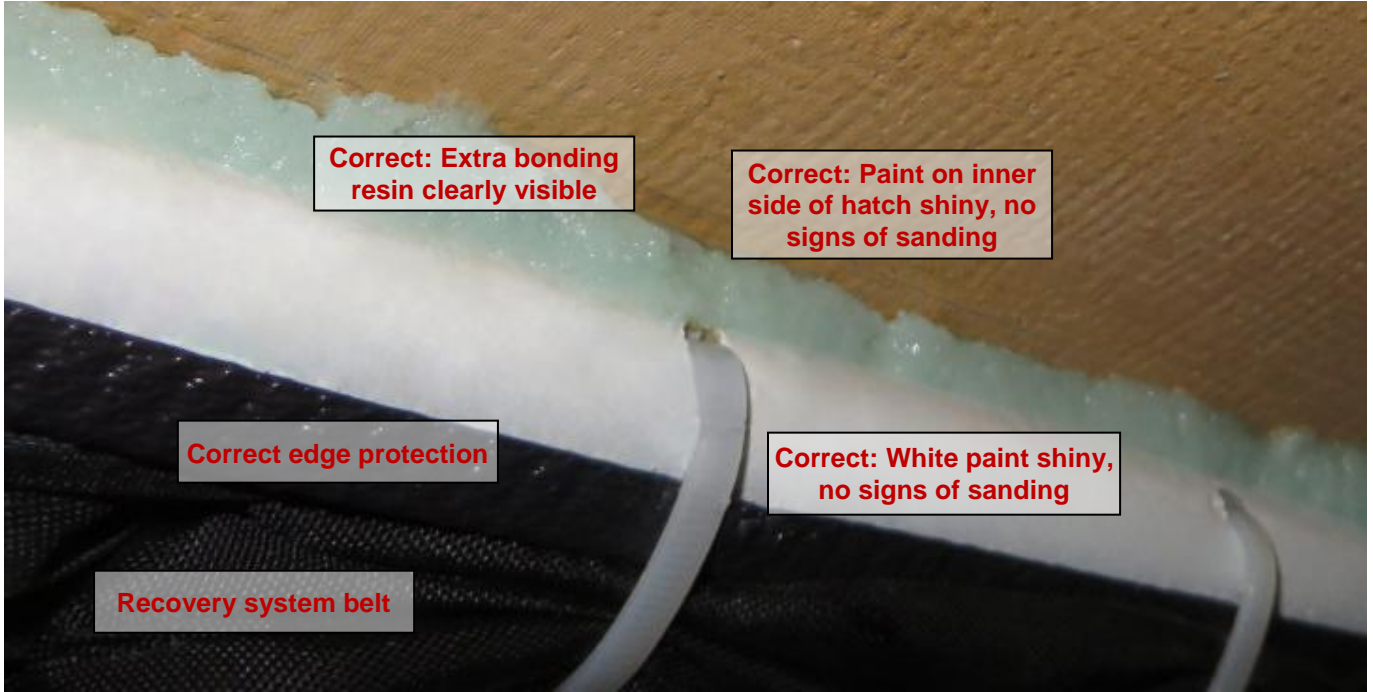
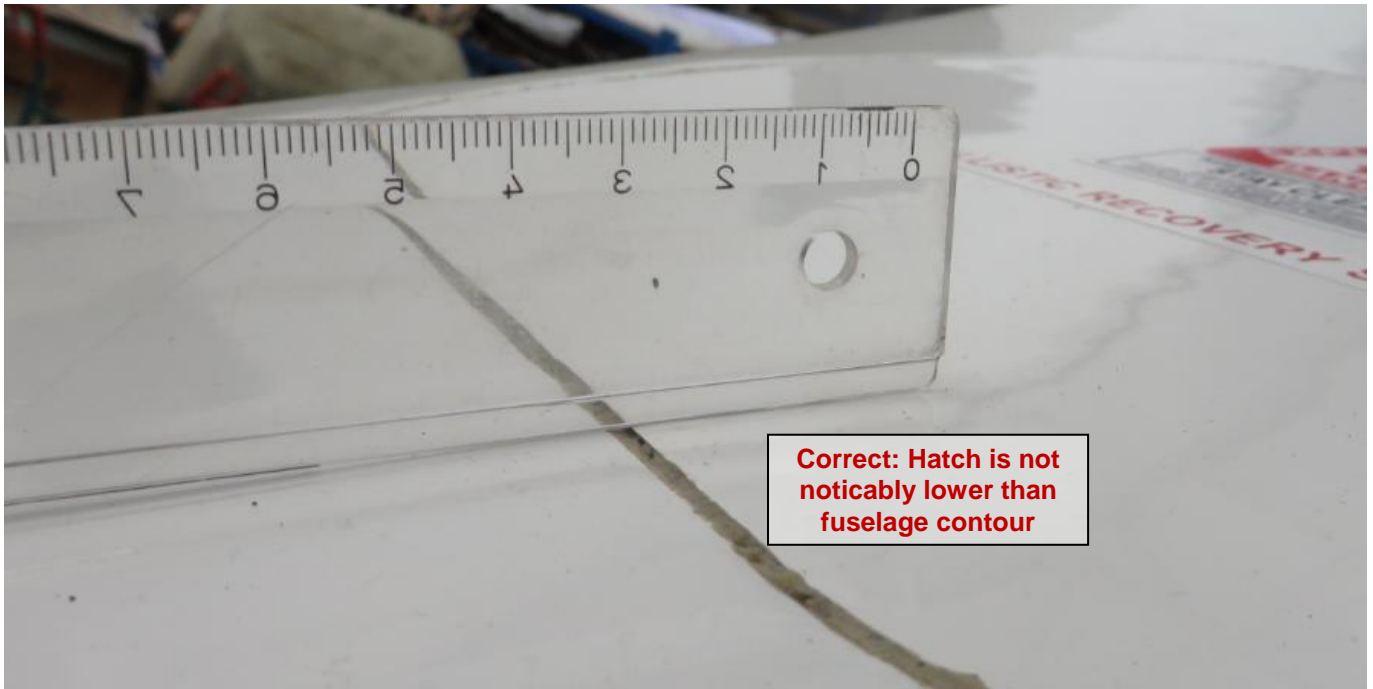
**Correct** installation of the extraction hatch is given when (see Fig. 3):

- The paint surface of both:
  - o the fuselage flange that forms the extraction opening and
  - o the inner side of the hatch
 is painted and was not sanded prior to the installation of the hatch.
- The hatch is glued to the fuselage flange that forms the extraction opening using thickened resin with clearly visible excess thickened resin at the edges of the installation. The thickened resin is non-transparent and has a more white color.
- On the outside the hatch is more flush with the fuselage surface. This is a sign for the thickness of the thickened resin in-between the opening flange and the hatch.
- The lower edge of the fuselage flange that forms the extraction opening is covered with black plastic edge protection with metal inlay (visible only at the ends), and this edge protection cannot be easily slipped off the edge of the flange.

Fig. 3 – Sample view a **correct** installation showing the listed details

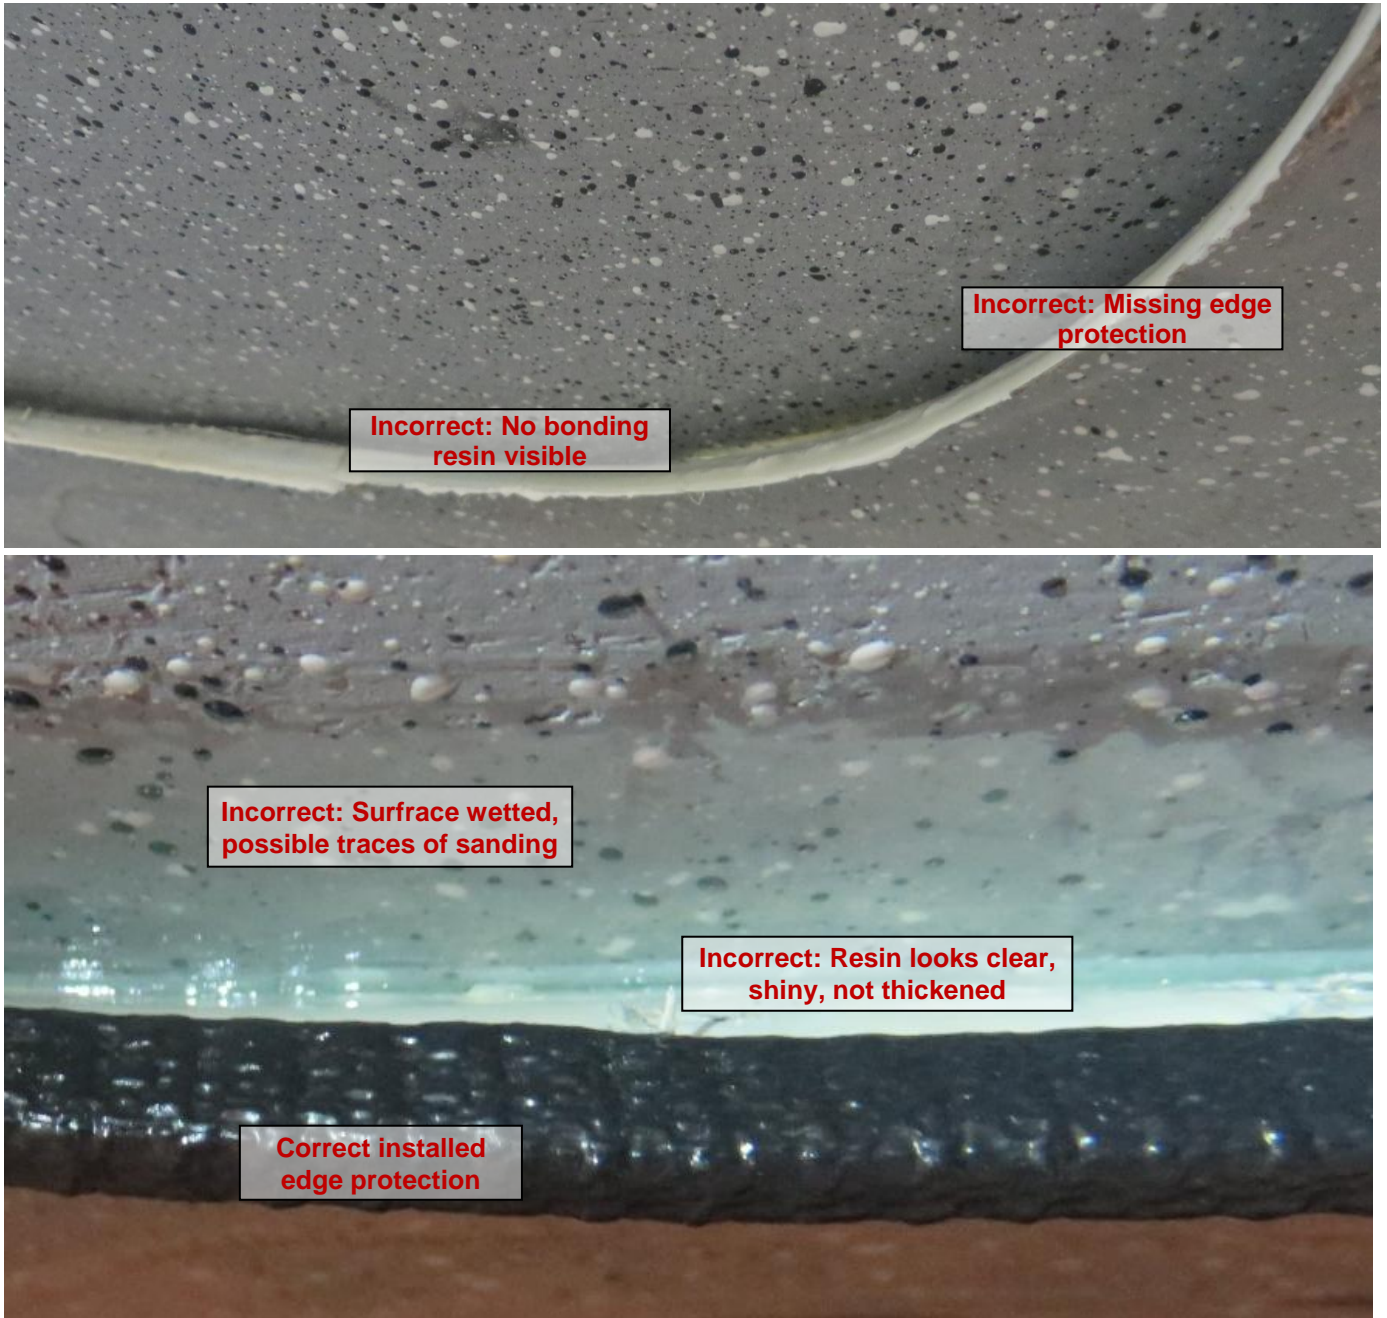
**Wrong** installation of the extraction hatch is given when any one of the following listed aspects is identified (see Fig. 4):

- The inner paint surface of the hatch shows signs of sanding or removed paint right next to the gluing area of the hatch
- The painted surface of the fuselage flange that forms the extraction opening shows signs of sanding or removed paint right next to the gluing area of the hatch

- There are no traces at all of excess thickened resin at the edges of the installation; possibly visible excess material leaves the impression of un-thickened resin which looks clear, transparent, possibly slightly blue

- Excess material that is visible on the inner surface is elastic like Acrylic, RTV Silicone or similar sealant
- Elastic tape is used to cover the edges of the opening from outside

- The hatch is clearly recessed below the fuselage contour around the opening. This is a sign for the possibility of non- thickened resin in-between the flange and hatch, which can mean that the hatch is incorrectly glued, with only plain resin without the required fillers.

- The plastic edge that covers the lower edge of the fuselage flange is missing in part or in full, or slides off easily.

**▲ Warning:** Any one of the signs identified here is possibly sufficient to make the installation incorrect, independent from other aspects looking correct. In case of doubt contact Flight Design with supporting picture documentation for clarification.

Fig. 4 – Sample view a **wrong** installation showing examples of the listed details

1. Check that the outside edge of the hatch is not covered with adhesive tape. In case you find adhesive tape, remove completely before conduct of the subsequent steps. When the hatch is not properly attached following removal of any adhesive tape, the hatch is considered as wrong installed, must be removed and re-installed.

- a. When the protection is present but slides off easily, use pliers to carefully squeeze the slot of the edge protection (this slightly bends the metal inlay inside and creates better grip on the flange), and re-install the edge protection.

- b. Test again if the edge protection now stays in place.
  - c. If this does not help, or if the edge protection is missing fully or in part, get a new edge protection from Flight Design and install.

### 3.3.4 In Case of a Wrong Installed Hatch

In case of a non correct installation, and when the aircraft is at a workshop adequately qualified for the re-installation of the hatch, remove the installed hatch according to the following instructions.

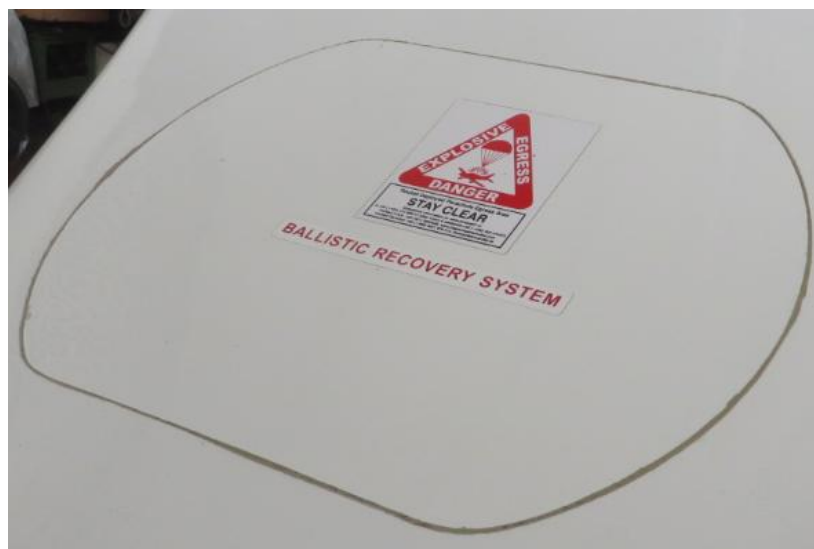
Prior to completion of this SB, and after correction of a possibly incorrect installation of the hatch, verify that the egress hatch is marked in a correct way with a warning label. The warning label must be legibly attached directly to the outside of the hatch.

The relevant warning labels for the systems installed to Flight Design aircraft are provided by the Airframe Emergency Parachute System. Fig. 5 shows the label provided by BRS for this purpose.

Fig. 5 – Sample view of warning label provided by BRS
