SERVICE BULLETIN

Rudder Centering Fork - Control Stop Replacement

SB-LTUL-CTLS-04

Model: CTLS

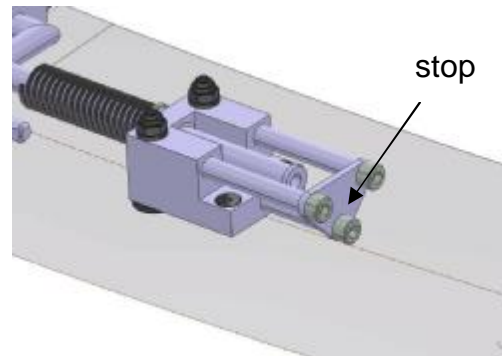
This is the rudder stop system that was installed to the CTLS affected by this SB ex factory. In this system the stop is provided to the rear end of the rudder centering fork, installed to the tunnel, below the instrument board. See following Fig. 1 and Fig. 2 for illustration.

This system is the system affected by this SB.

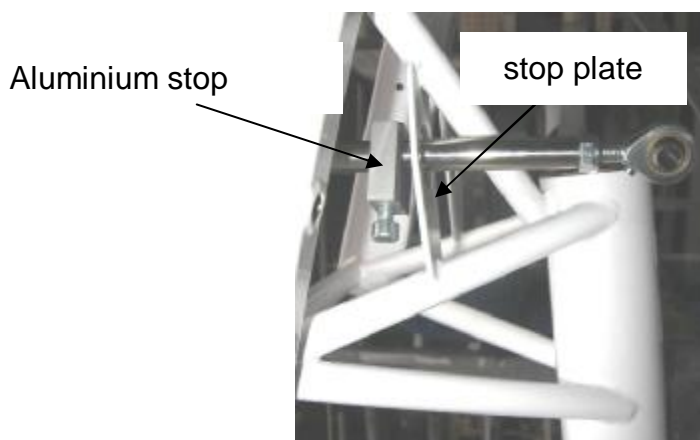
The rudder stop plates provide rudder stop not at the rudder centering fork. Aluminium stops, positioned to the control rods that connect the pedals with the nose gear steering, come to a stop against two stop plates welded to the big engine mount, in front of the firewall. See following Fig. 4 for illustration (only partially installed situation).

This stop device represents the valid type design previous to the introduction of the old fork stop system. It has been replaced in production due to the more complex adjustment principle, coupling with the rudder control rope pretension. On aircrafts where the welded stop plates are still available, this previous stop system shall be used again as it is easier and faster to be installed. The modification procedure is provided by this SB.

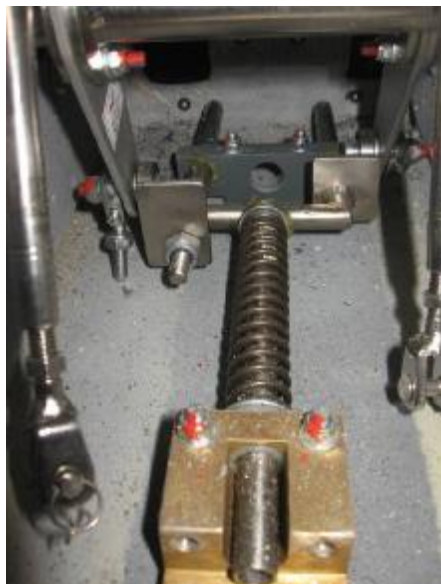
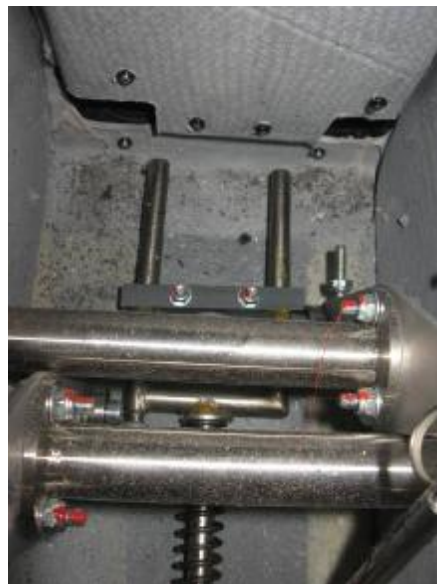
1. The rudder centering fork is not deformed, fork tubes are straight, and fork plates (small square plates shown on the fork, Fig. 5) are not bent or deformed. The correct configuration is shown on Fig. 5, 6;

When deformation is detected at the rudder centering fork, this fork must be exchanged.
