Service Bulletin

SB-LTUL-CTLS-14, SB-LTUL-CTSL-06, Revision 00

Dynon Autopilot Servo SV42T Inspection and Replacement of Linear Actuator Servo **Pulley** SB-LTUL-CTLS-14

Model: CTLS/CT Supralight

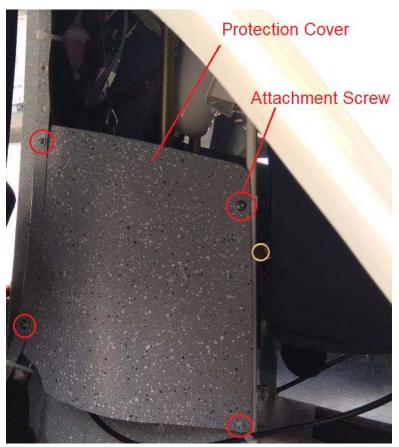
Fig. 2

- Open left luggage door;
- Remove protection cover of control system by unscrewing attachment screws M4, marked by red circles on Fig. 2.

• **Note:** On Fig.2 shown installation of protection cover on CTSL plane. Installations of protection cover on CTLS are very similar.

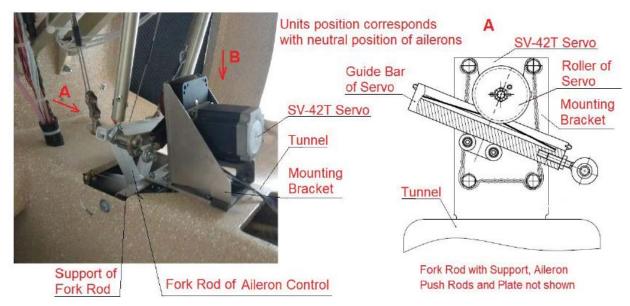
Fig. 3. Installation of Roll Servo SV42T to CTLS

Installations of autopilot roll servo SV42T to CTLS and to CT Supralight planes is very similar with some small differences. With this the servo pulley removal procedure provided below is applicable for both airplane types. Installation of system is shown on Fig. 3.

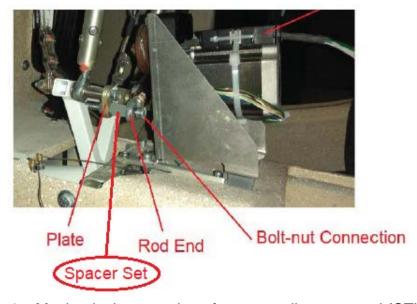
Fig. 4a. Mechanical connection of servo to aileron control (CTLS)

Detach servo guide bar with rod end from an aileron control system by unscrewing of the boltnut connection (Fig. 4a and Fig. 4b)

1. Unloose Lock Nut of the servo Rod End (Fig. 4) by turning of nut counterclockwise approx. for 15°-30° (it should be enough to screw-out rod end from guide bar later). Keep Lock Nut in such position on the Rod End. Do not screw out nut more so as will help install rod end properly at unit assembling.

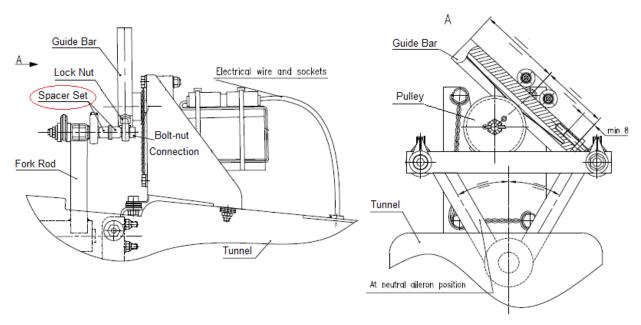
Fig. 4b. Mechanical connection of servo to aileron control (CTSL)

- 1. Mount the new pulley with guide bar on the shaft of servo as described in [2].
- 2. Screw-in the rod end with lock nut to the guide bar up to lock nut by hand. Do not tight lock nut at this moment.
- Note: Guide bar has thread bores for rod end on both ends. Verify the correct position of guide bar relatively to the pulley. The correct position for CTLS installation is shown on Fig. 3 (guide bar under the pulley). The correct position for CTSL installation is shown on Fig. 4b (guide bar above the pulley).
