<b>SERVICE BULLETIN</b>	
	<b>Flight Design GmbH</b> Sielminger Str. 51 D-70771 L.-Echterdingen Tel +49 (0)711 90287-0 Fax +49 (0)711 90287-99 E-Mail: <a href="mailto:airworthiness@flightdesign.com">airworthiness@flightdesign.com</a>	<b>SB-SECS-CTSW-05</b> <b>Revision 00</b>
		Date of Initial Publication: <b>30-Nov-2009</b> Publication Date of this Revision: <b>30-Nov-2009</b>

## Stabilizer Rear Wall Stiffening SB-SECS-CTSW-05

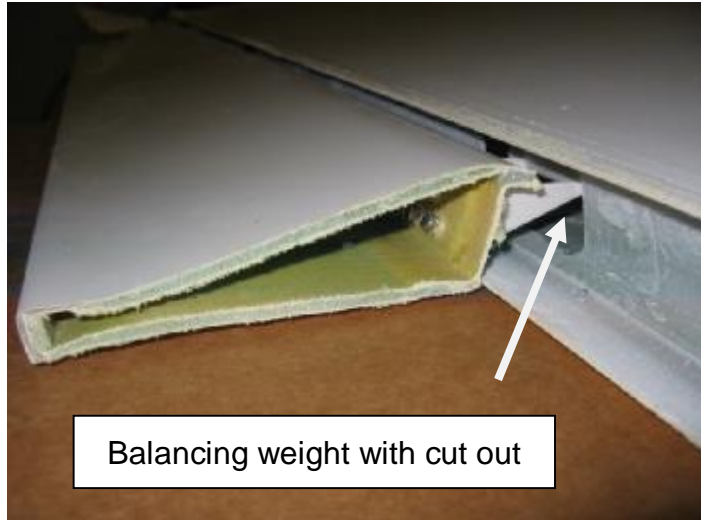
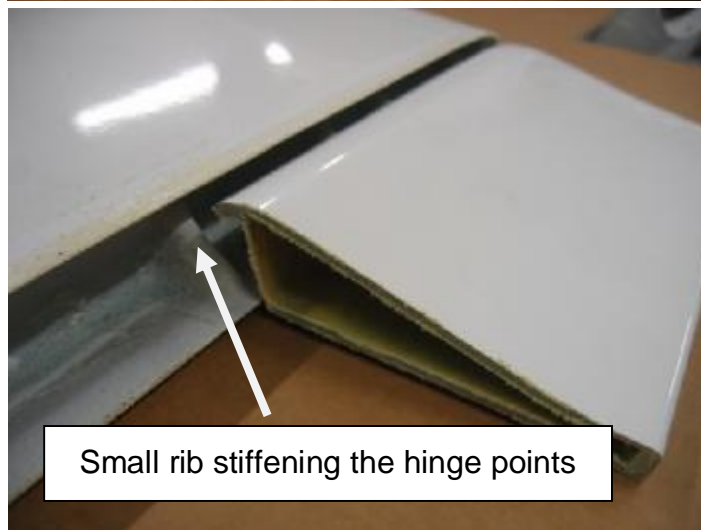
#### 4.2 Pictures

Increasing play in the trim tab control system can lead to vibrations in the trim tab in flight at high speeds. This vibration can be clearly felt by the pilot when exceeding a certain speed and stops again when slowing down.

Pictures in the Appendix of this SB illustrate balancing weights with cut outs and the small ribs, which supports each hinge point.

Stiffening of the rear wall of the stabilizer by installation of ribs in the cut-outs for the balancing weights, and direct support of the individual hinge points with small ribs.
