<b>FLIGHT DESIGN</b> <small>LIFTAIR®</small>	<b>Safety Alert</b>			
<b>Flight Design general aviation GmbH</b> Am Flugplatz 3, D-99820 Hörselberg Hainich Airfield Eisenach-Kindel Web: <a href="http://www.flightdesign.com">www.flightdesign.com</a> ; Phone: +49 36920 7530-10 E-mail: <a href="mailto:airworthiness@flightdesign.com">airworthiness@flightdesign.com</a>	SA-ASTM-CTLS-05	SA-LTUL-CTLS-06	---	SA-ELA-CTLS-01
	---	---	---	---
	SA-ASTM-CTSW-07	SA-LTUL-CTSW-09	SA-SECS-CTSW-07	---
	---	SA-LTUL-CT Supralight-05	SA-SECS-CT Supralight-01	---
	SA-ASTM-CT2K-05	SA-LTUL-CT2K-06	SA-SECS-CT2K-06	---
	SA-ASTM-CT-02	SA-LTUL-CT-06	SA-SECS-CT-03	---
	Revision 00			
	Date of Initial Publication:		<b>26-Oct-2023</b>	
	Publication Date of this Revision:		<b>26-Oct-2023</b>

# Safety Alert

## Checking Nut on Stabilizer Control

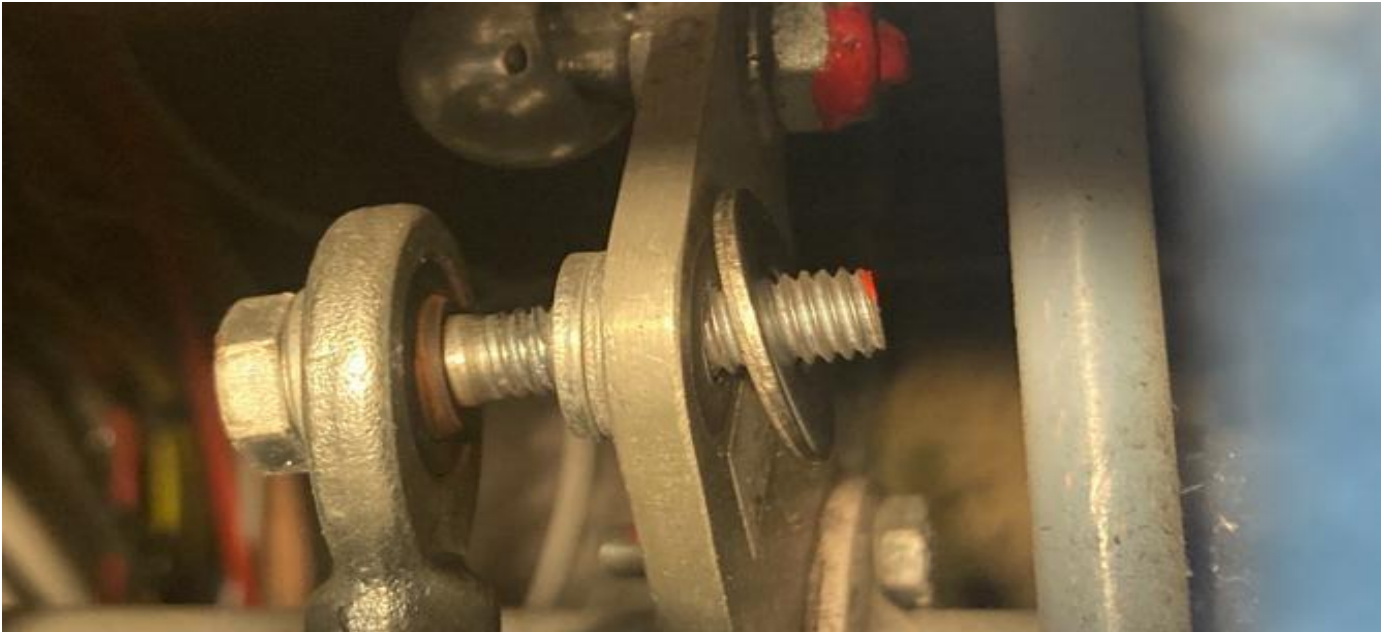
The nut on the bolted connection of the forward bell crank in the cabin connecting the push-pull cable for the stabilizer control has become loose on a CTLSi certified as an ultralight.

It was not possible to identify, whether this was a production or maintenance fault.

This is a common design feature on all versions of the CT (except of CT-HL) and therefore affects any CT model (except of CT-HL) with any certification basis.

The connection must be checked. In case of non-conformity with type design, nut must be replaced.

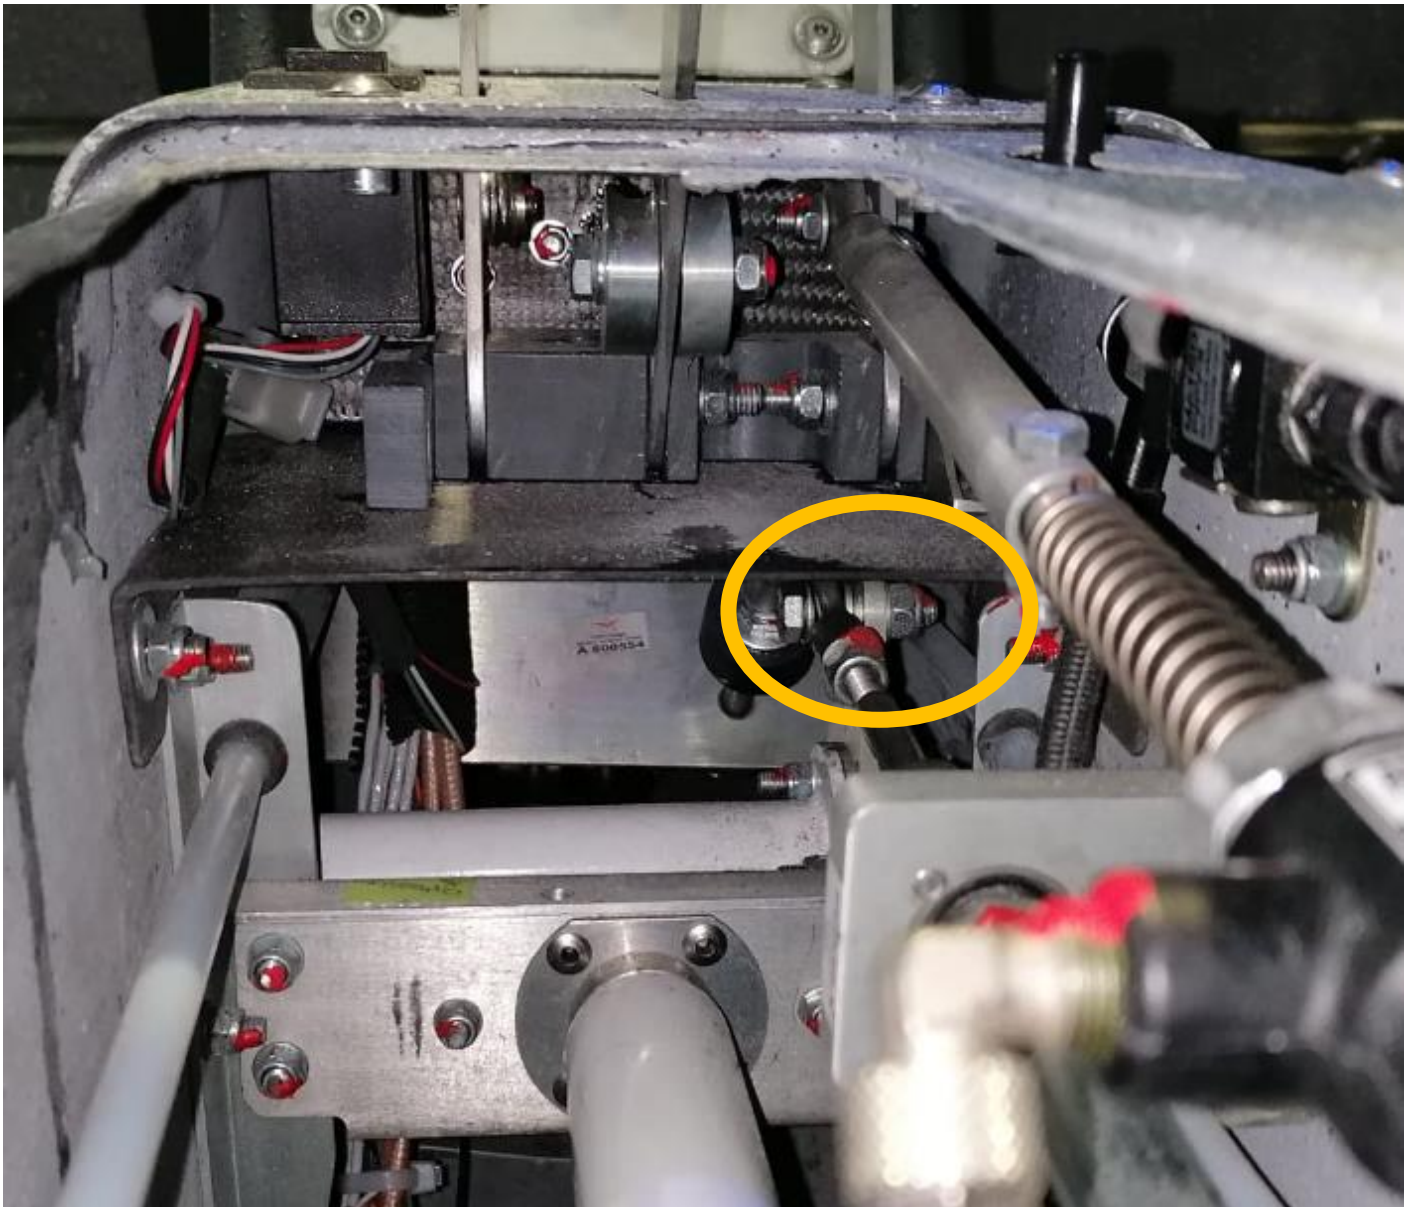
Use a flashlight and pull back the control stick. Check if the ball/rod end is correctly attached to the bell crank. See yellow marks in the picture below. A self-locking nut (nyloc stop nut) must be safely installed!

In the case a self-locking nut is safely installed, reinstall the cover of the center console make a logbook entry. Release the aircraft back to service in accordance with section 1.9.

In the case the nut is loose or a standard, non locking nut is installed, follow instructions of section 3.2.
