<b>SERVICE BULLETIN</b>	
	<b>Flight Design GmbH</b> Sielminger Str. 51 D-70771 L.-Echterdingen Tel +49 (0)7021 / 80460-0 Fax +49 (0)7021 / 80460-69 E-Mail: <a href="mailto:airworthiness@flightdesign.com">airworthiness@flightdesign.com</a>	<b>SB-ASTM-CTLS-03</b> <b>Revision 00</b>

# SERVICE BULLETIN

## Rudder Centering Fork - Control Stop Replacement

### SB-ASTM-CTLS-03

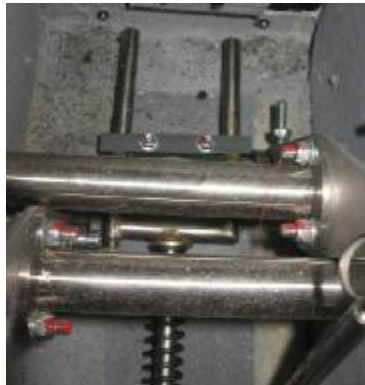
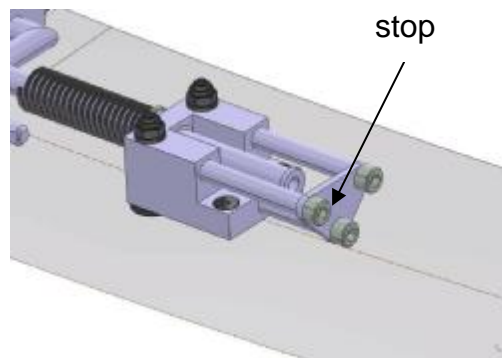
This is the rudder stop system that was installed to the CTLS affected by this SB ex factory. In this system the stop is provided to the rear end of the rudder centering fork, installed to the tunnel, below the instrument board. See following Fig. 1, 2 for illustration.

This system is the system affected by this SB.

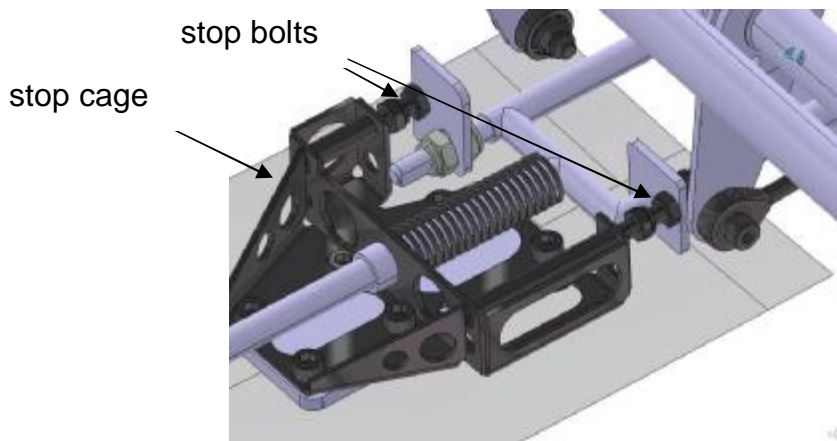
The new fork stop system provides a stop not to the rear end of the rudder centering fork, but to the thrust plates where the rudder centering fork contacts the bolt heads from the rudder pedal levers. The variant is clearly recognizable by the steel welded cage that provides the stops by means of adjustable bolts. See following Fig. 3 for illustration.

This stop device represents the valid type design and is used in serial production at the time of issuing of this SB. Only on aircrafts where the Rudder Stop Plates as by 3.1.3 cannot be used, this new fork stop system must be installed following this SB.

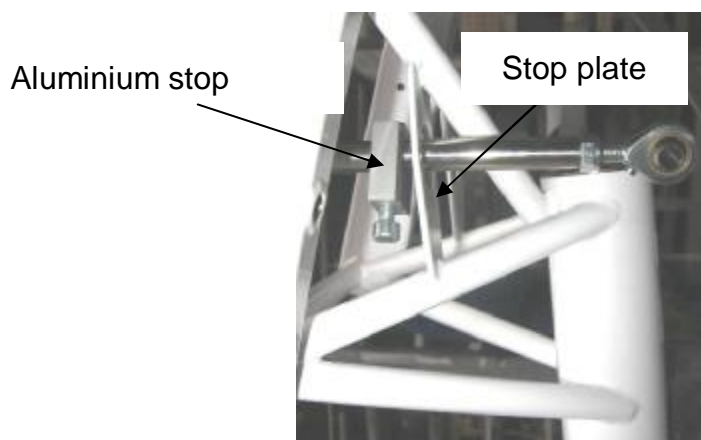
The rudder stop plates provide rudder stop not at the rudder centering fork. Aluminium stops, positioned to the control rods that connect the pedals with the nose gear steering, come to a stop against two stop plates welded to the big engine mount, in front of the firewall. See following Fig. 4 for illustration (only partially installed situation).

This stop device represents the valid type design previous to the introduction of the old fork stop system. It has been replaced in production due to the more complex adjustment process, coupling with the rudder control rope pretension. On aircrafts where the welded stop plates are still available, this previous stop system shall be used again following SB [2], as it is easier and faster to be installed. However, aircraft S/N affected by this SB do not have the welded stop plates installed any more. Therefore this variant cannot be used any more for these aircraft.

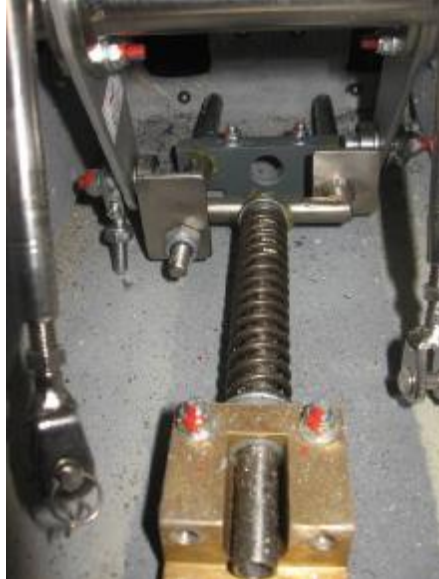
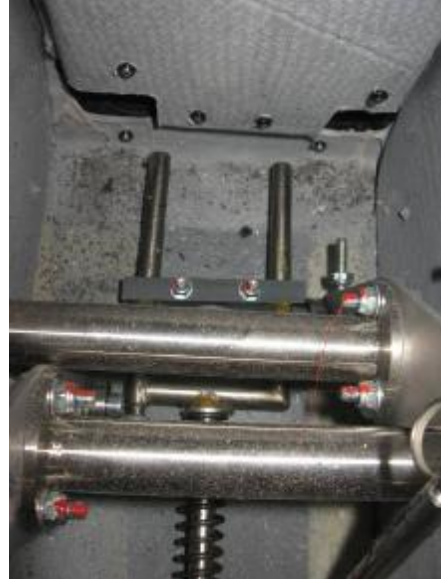
Check if the rudder centering fork is not deformed, fork tubes are straight, and fork plates (small square plates shown on the fork, Fig. 5) are not bent or deformed. The correct configuration is shown on Fig. 5, 6;

When the rudder centering fork is deformed, exchange now against a new rudder centering fork. Re-use the spring from the damaged rudder centering fork and make certain that the position of the left side fork plate (Fig. 5 above) is adjusted to the same position as on the original fork.

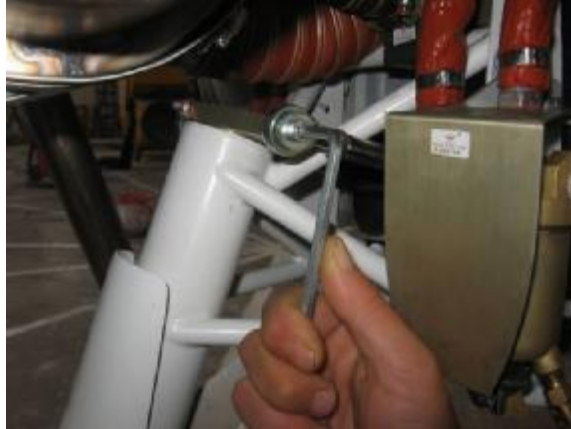
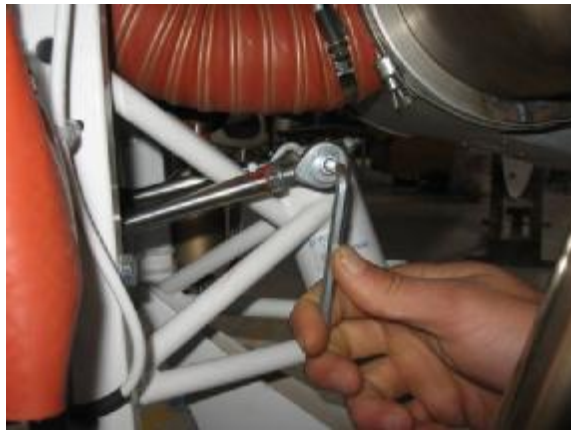
Detach the pushrods of the nose wheel steering – unscrew two (2), DIN 912 M6 bolts from the left and right sides (Fig. 7, 8).

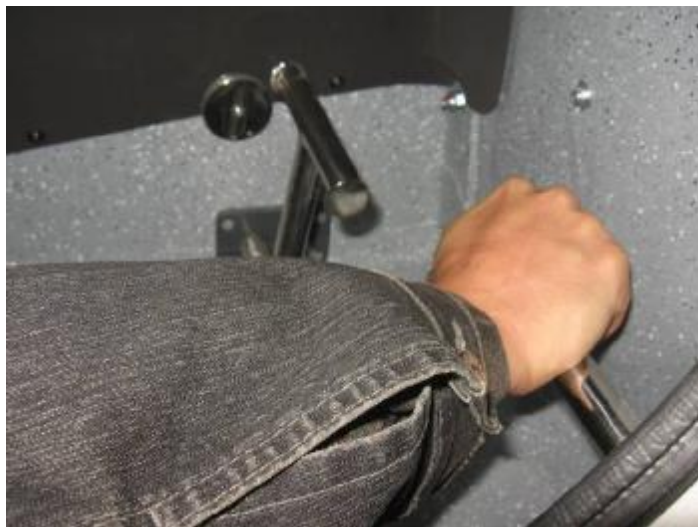
Fig. 9

**Warning:** Keep pedals in neutral position during removal of the rods (Fig. 9). The spring force of the rudder centering fork will push the pedals towards the seats as soon as one of the pushrods is released. It is best done with one person holding the pedals and carefully releasing them after detachment of the pushrods.

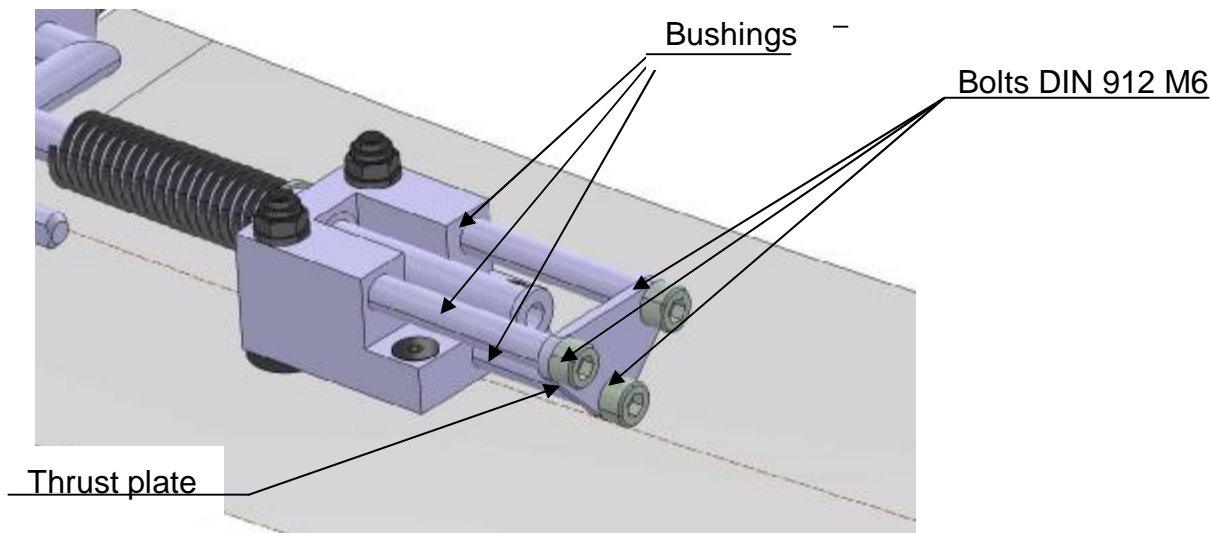
Fig. 10

The old fork stop system, that guides the rear end of the rudder centering fork, must be uninstalled when the rudder stop plates are installed. To do this, remove the three bushings, bolts and thrust plate shown in Fig 10 from the fork mount block. Unscrew three (3) DIN 912 M6 bolts (Fig. 10). Discard these parts.

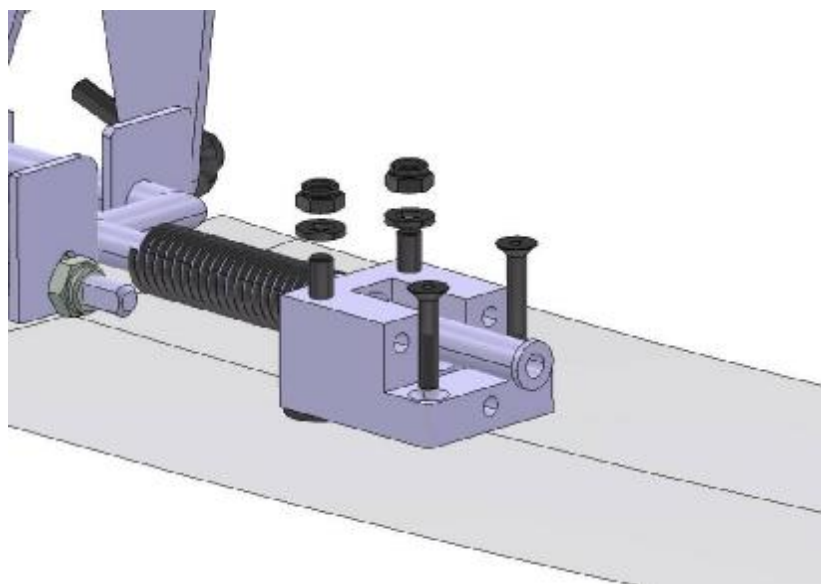
Fig. 11

Remove the rear aluminum fork mount block from the lower fuselage skin by unscrewing the 4 bolts as shown in Fig. 11.

**Warning:** The spring installed to the rudder centering fork provides a pretension to the system and will push the aluminium block to the rear, once all bolts are removed.

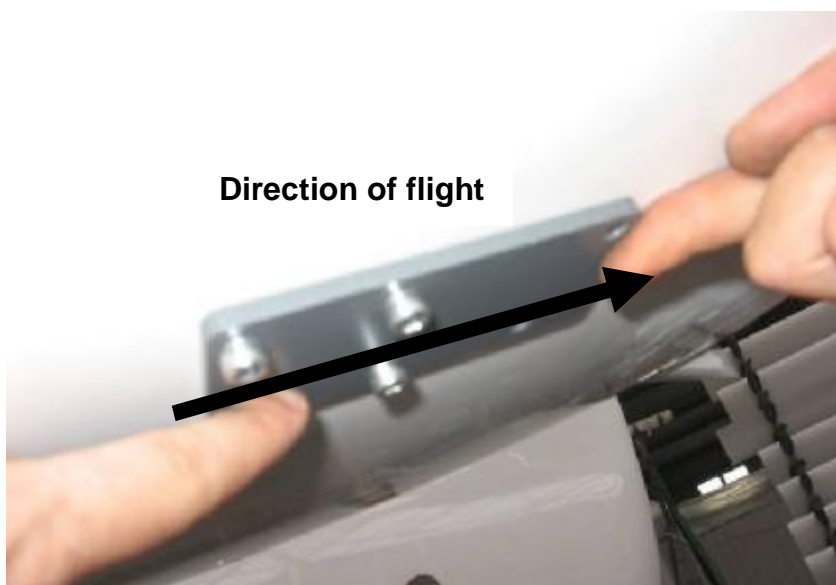
Fig. 12

Temporarily install PVC plate KF27200223 from the outside to the bottom fuselage using four (4) bolts (Fig. 12).

**Warning:** Installation must be exactly in the same position as the installation will be later on in the aircraft, so not turned upside down. When looking in direction of flight, the most forward hole on the left side must be rear of the most forward hole on the right side. Pay special attention, when drilling the holes you look from below In case of doubt use the new fork stop cage to cross check. See Fig 6.

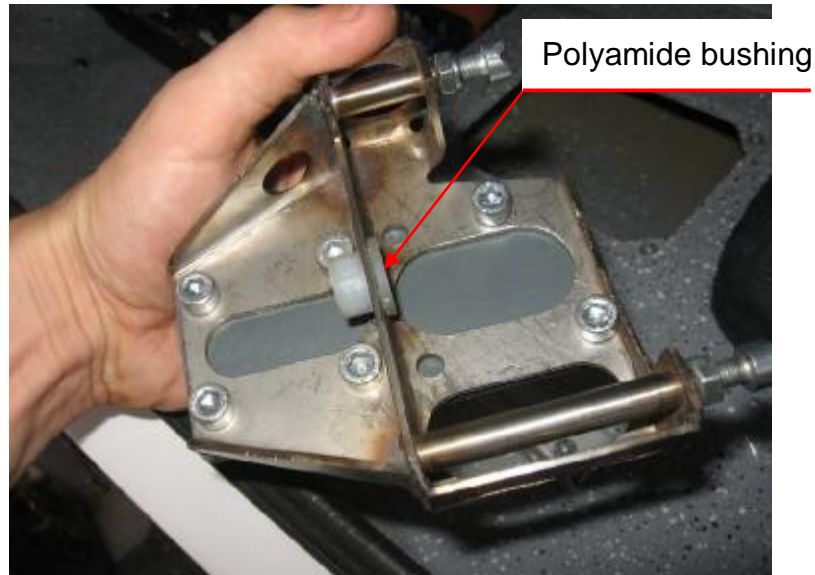
Fig. 13

Remove polyamide bushing from the aluminum support that was uninstalled in step 3.3.3. Install this polyamide bushing to the guide hole of the new rudder stop device (Fig. 13).

Take the new fork stop system cage and place the PVC plate on the lower side and insert the 6 attachment bolts (Fig 13).

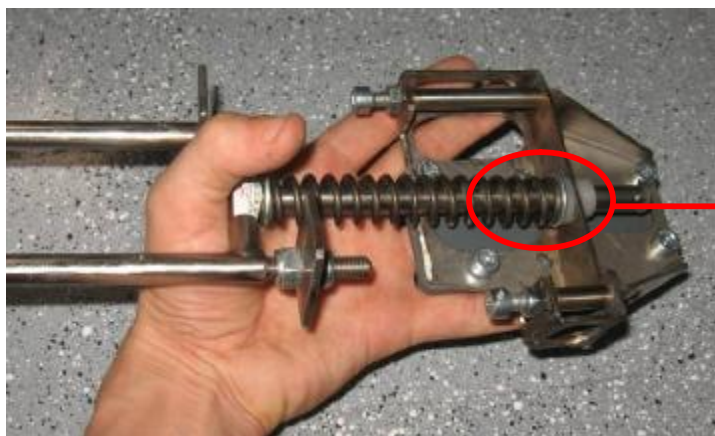
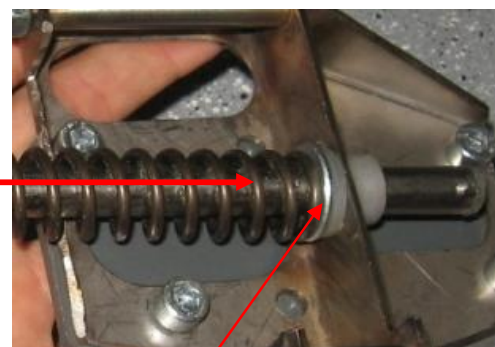
Fig. 14

Insert rear guide of the rudder centering fork to the new fork stop system cage as shown in Fig 14.

**Warning:** Install one (1) washer between the spring and polyamide bush (Fig. 14)

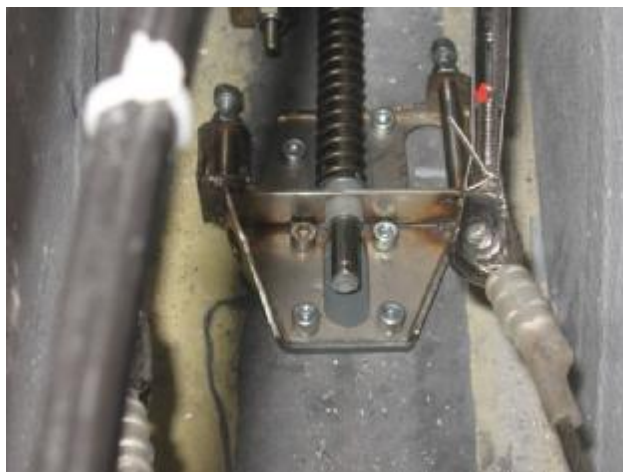
Fig. 15

Now the set of rudder centering fork and new fork stop system cage can be positioned into the fuselage. The fork is inserted to the front fork guide and the new fork stop system cage is attached to the six (6) attachment points on the fuselage floor (Fig. 15).

Install washers DIN 9021 6.3 mm from the outside of fuselage. Install new self-locking nuts M6 on each bolt. Apply tightening torque: 9 Nm.

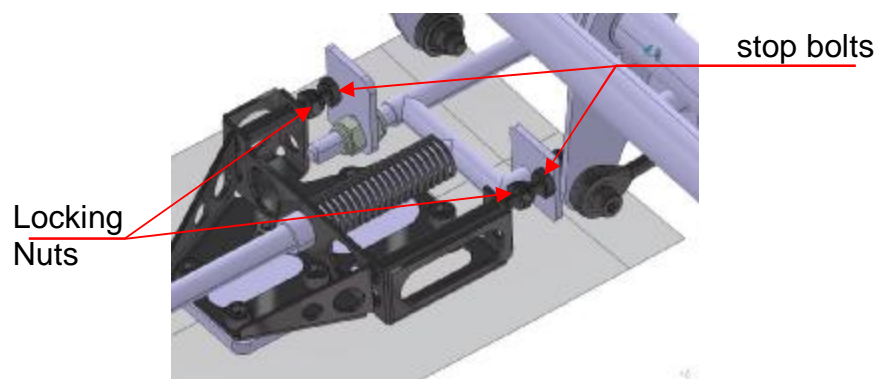
Fig. 16

Adjustment of the rudder stops is achieved by changing the length of the stop bolts, inserted to the new fork stop system cage (Fig. 16). When deflected, the fork plates are pushed against these stop bolts. Changing both of the bolts allows increasing or decreasing the maximum rudder deflection.

**Warning:** The stops on both sides of the new system must be installed so that the stop at the side where the pedal is deflected touches the centering fork first or at the same time as the other side does. The opposite stop from the deflected pedal cannot touch first.

After finishing of the adjustment tighten the locking nuts (Fig 16) on the stop bolts.

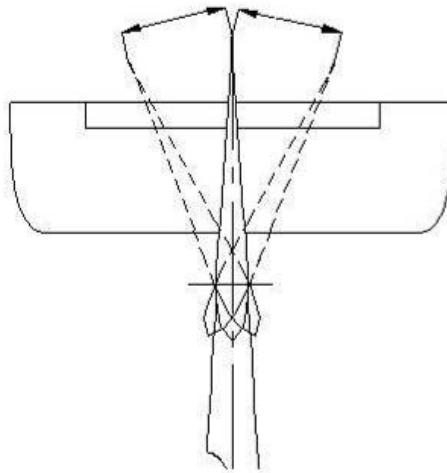
Fig. 17

Maximum rudder deflection is measured at the lower trailing edge of the rudder as shown in Fig 17.

206-228mm (8-9 in)

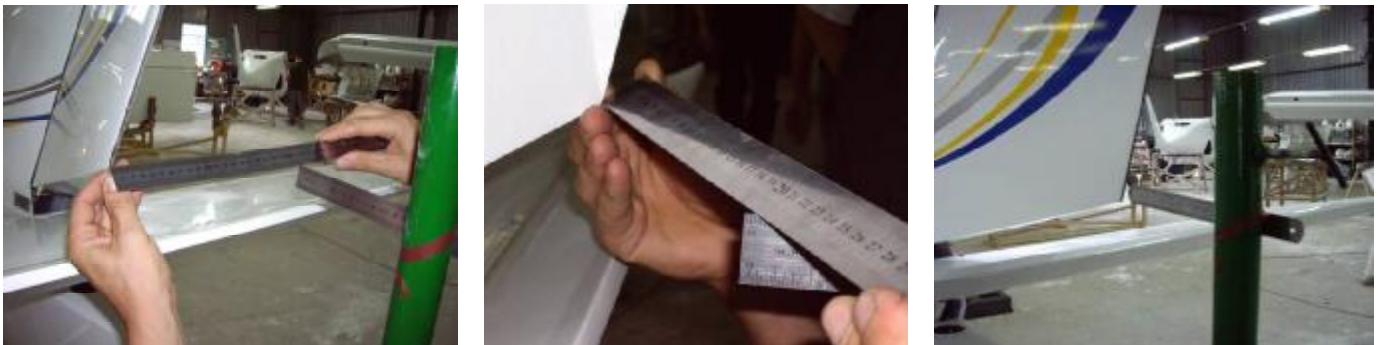
Fig. 18

To measure this deflection, position a pointer/reference marking the rear lower edge of the rudder in the neutral position. Then deflect the rudder by pushing the pedals up to the stop and measure distance between pointer and deflected rear edge of the rudder (Fig. 18).
