Service Bulletin

SB-LTUL-CTLS-14, SB-LTUL-CTSL-06, Revision 00

Dynon Autopilot Servo SV42T Inspection and Replacement of Linear Actuator Servo **Pulley** SB-LTUL-CTLS-14

Model: CTLS/CT Supralight

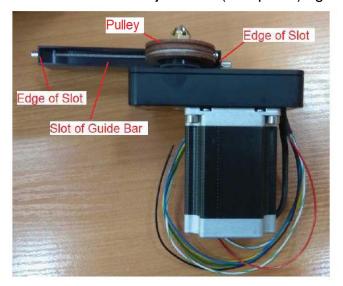
Fig. 6

- 3. Connect the rod end to the control system by the bolt-nut connection with spacer set. To be done in back order of item 2 of subchapter 3.3.4. Use the new self-locking nut p/n C9996334. Tight the bolt-nut connection with torque 9 Nm.
- 4. Verify that within the full range of aileron control system deflections (right-left) the pulley does not touch the end of the guide bar slot. If the pulley touches the end of the guide bar slot, adjust the rod end of the guide bar. Verify that the rod end thread is screwed in to the guide bar not less than 8mm.
- 5. After check and adjustment (if required) tighten a lock nut of the Rod End.

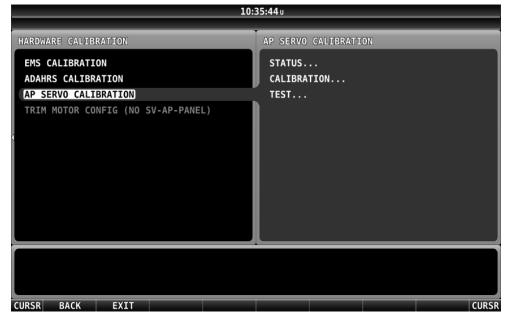
- 6. Perform servo calibration from Dynon Skyview:
 - Switch on the power and all avionic equipment together with autopilot circuit breaker;
 - Enter to the SYSTEM SETUP menu on the left SkyView display (SV);
 - Enter to submenu HARDWARE CALIBRATION > AP SERVO CALIBRATION > CALIBRATION. Then follow instructions on the screen.
