<b>FLIGHT DESIGN</b> <small>LIFTAIR®</small>	<b>Safety Alert</b>			
<b>Flight Design general aviation GmbH</b> Am Flugplatz 3, D-99820 Hörselberg Hainich Airfield Eisenach-Kindel Web: <a href="http://www.flightdesign.com">www.flightdesign.com</a> ; Phone: +49 36920 7530-10 E-mail: <a href="mailto:airworthiness@flightdesign.com">airworthiness@flightdesign.com</a>	SA-ASTM-CTLS-05	SA-LTUL-CTLS-06	---	SA-ELA-CTLS-01
	---	---	---	---
	SA-ASTM-CTSW-07	SA-LTUL-CTSW-09	SA-SECS-CTSW-07	---
	---	SA-LTUL-CT Supralight-05	SA-SECS-CT Supralight-01	---
	SA-ASTM-CT2K-05	SA-LTUL-CT2K-06	SA-SECS-CT2K-06	---
	SA-ASTM-CT-02	SA-LTUL-CT-06	SA-SECS-CT-03	---
	Revision 00			
	Date of Initial Publication:		<b>26-Oct-2023</b>	
	Publication Date of this Revision:		<b>26-Oct-2023</b>

# Safety Alert

## Checking Nut on Stabilizer Control

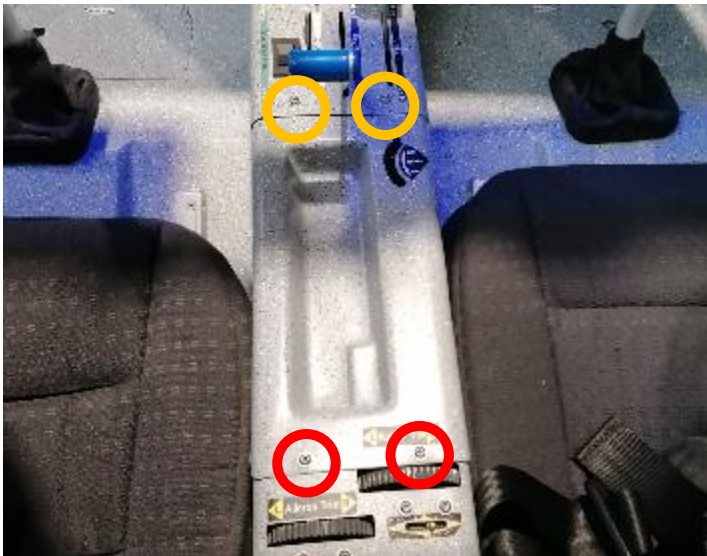
Open the rear cover of the center console. Take out the two hex bolts marked in red and loosen the two others marked yellow.

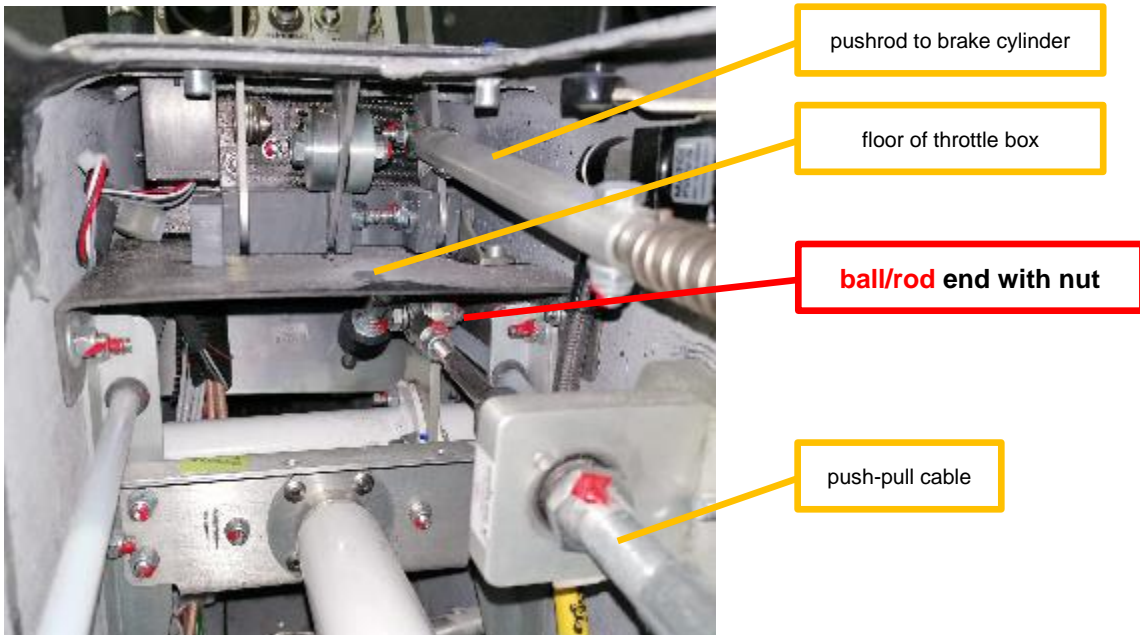
Identify the ball/rod end on the push-pull cable. The ball end is found underneath the throttle box.
