Radiator Isolator Mounts

SB-LTUL-CT2k-01;

SB-LTUL-CTSW-01

Technical Advice No.9 Rev 2

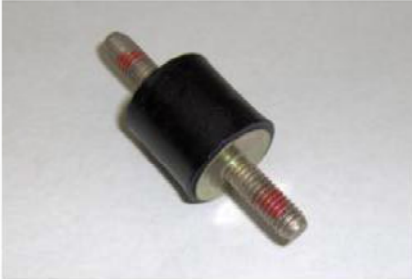
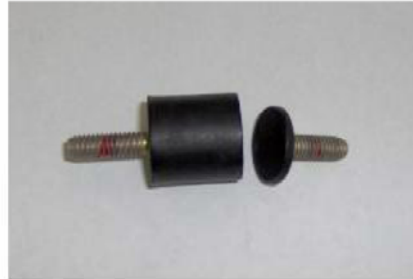
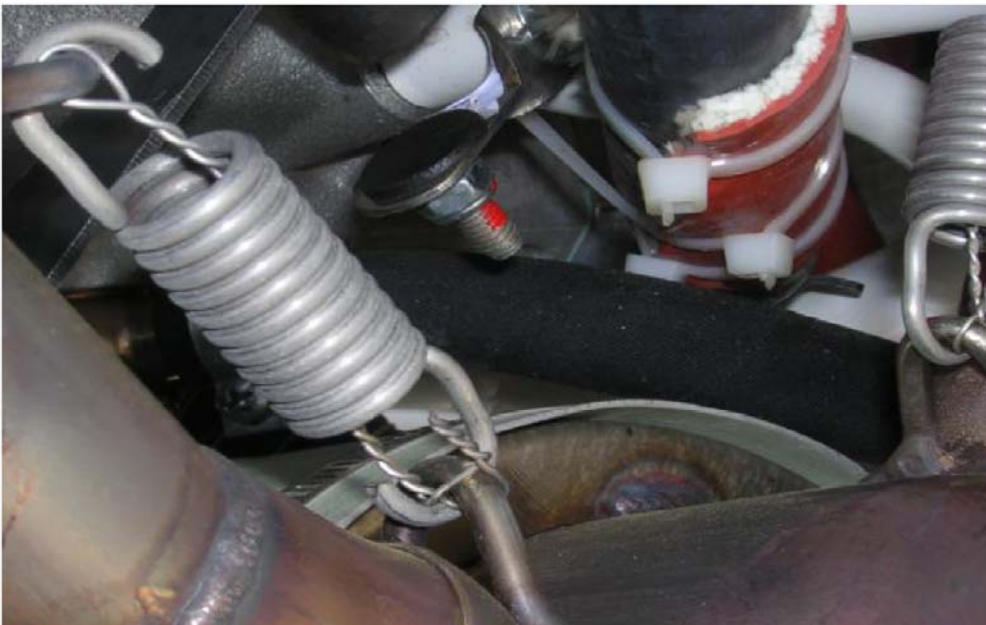
On four CT's has been discovered that the rubber mounts for to the radiator had broken.

Check the rubber mounts before next flight by moving the attachment points by hand. Inspecting this point must be performed as a part of the 50 hour inspection. This item will be added to the check list in the maintenance manual.
